# *The discovery of HMS Tiger* **The last 30-knotter** 10 August 2026

*This report outlines the discovery, identification and documentation of HMS Tiger, the last missing British 30-knot torpedo boat destroyer sunk in the English Channel, cut in two by a collision with the 9,800-tonne armoured cruiser HMS Berwick during night manoeuvres on 2 April 1908.*

**Project co-organised by Leo Fielding and Dan McMullen**

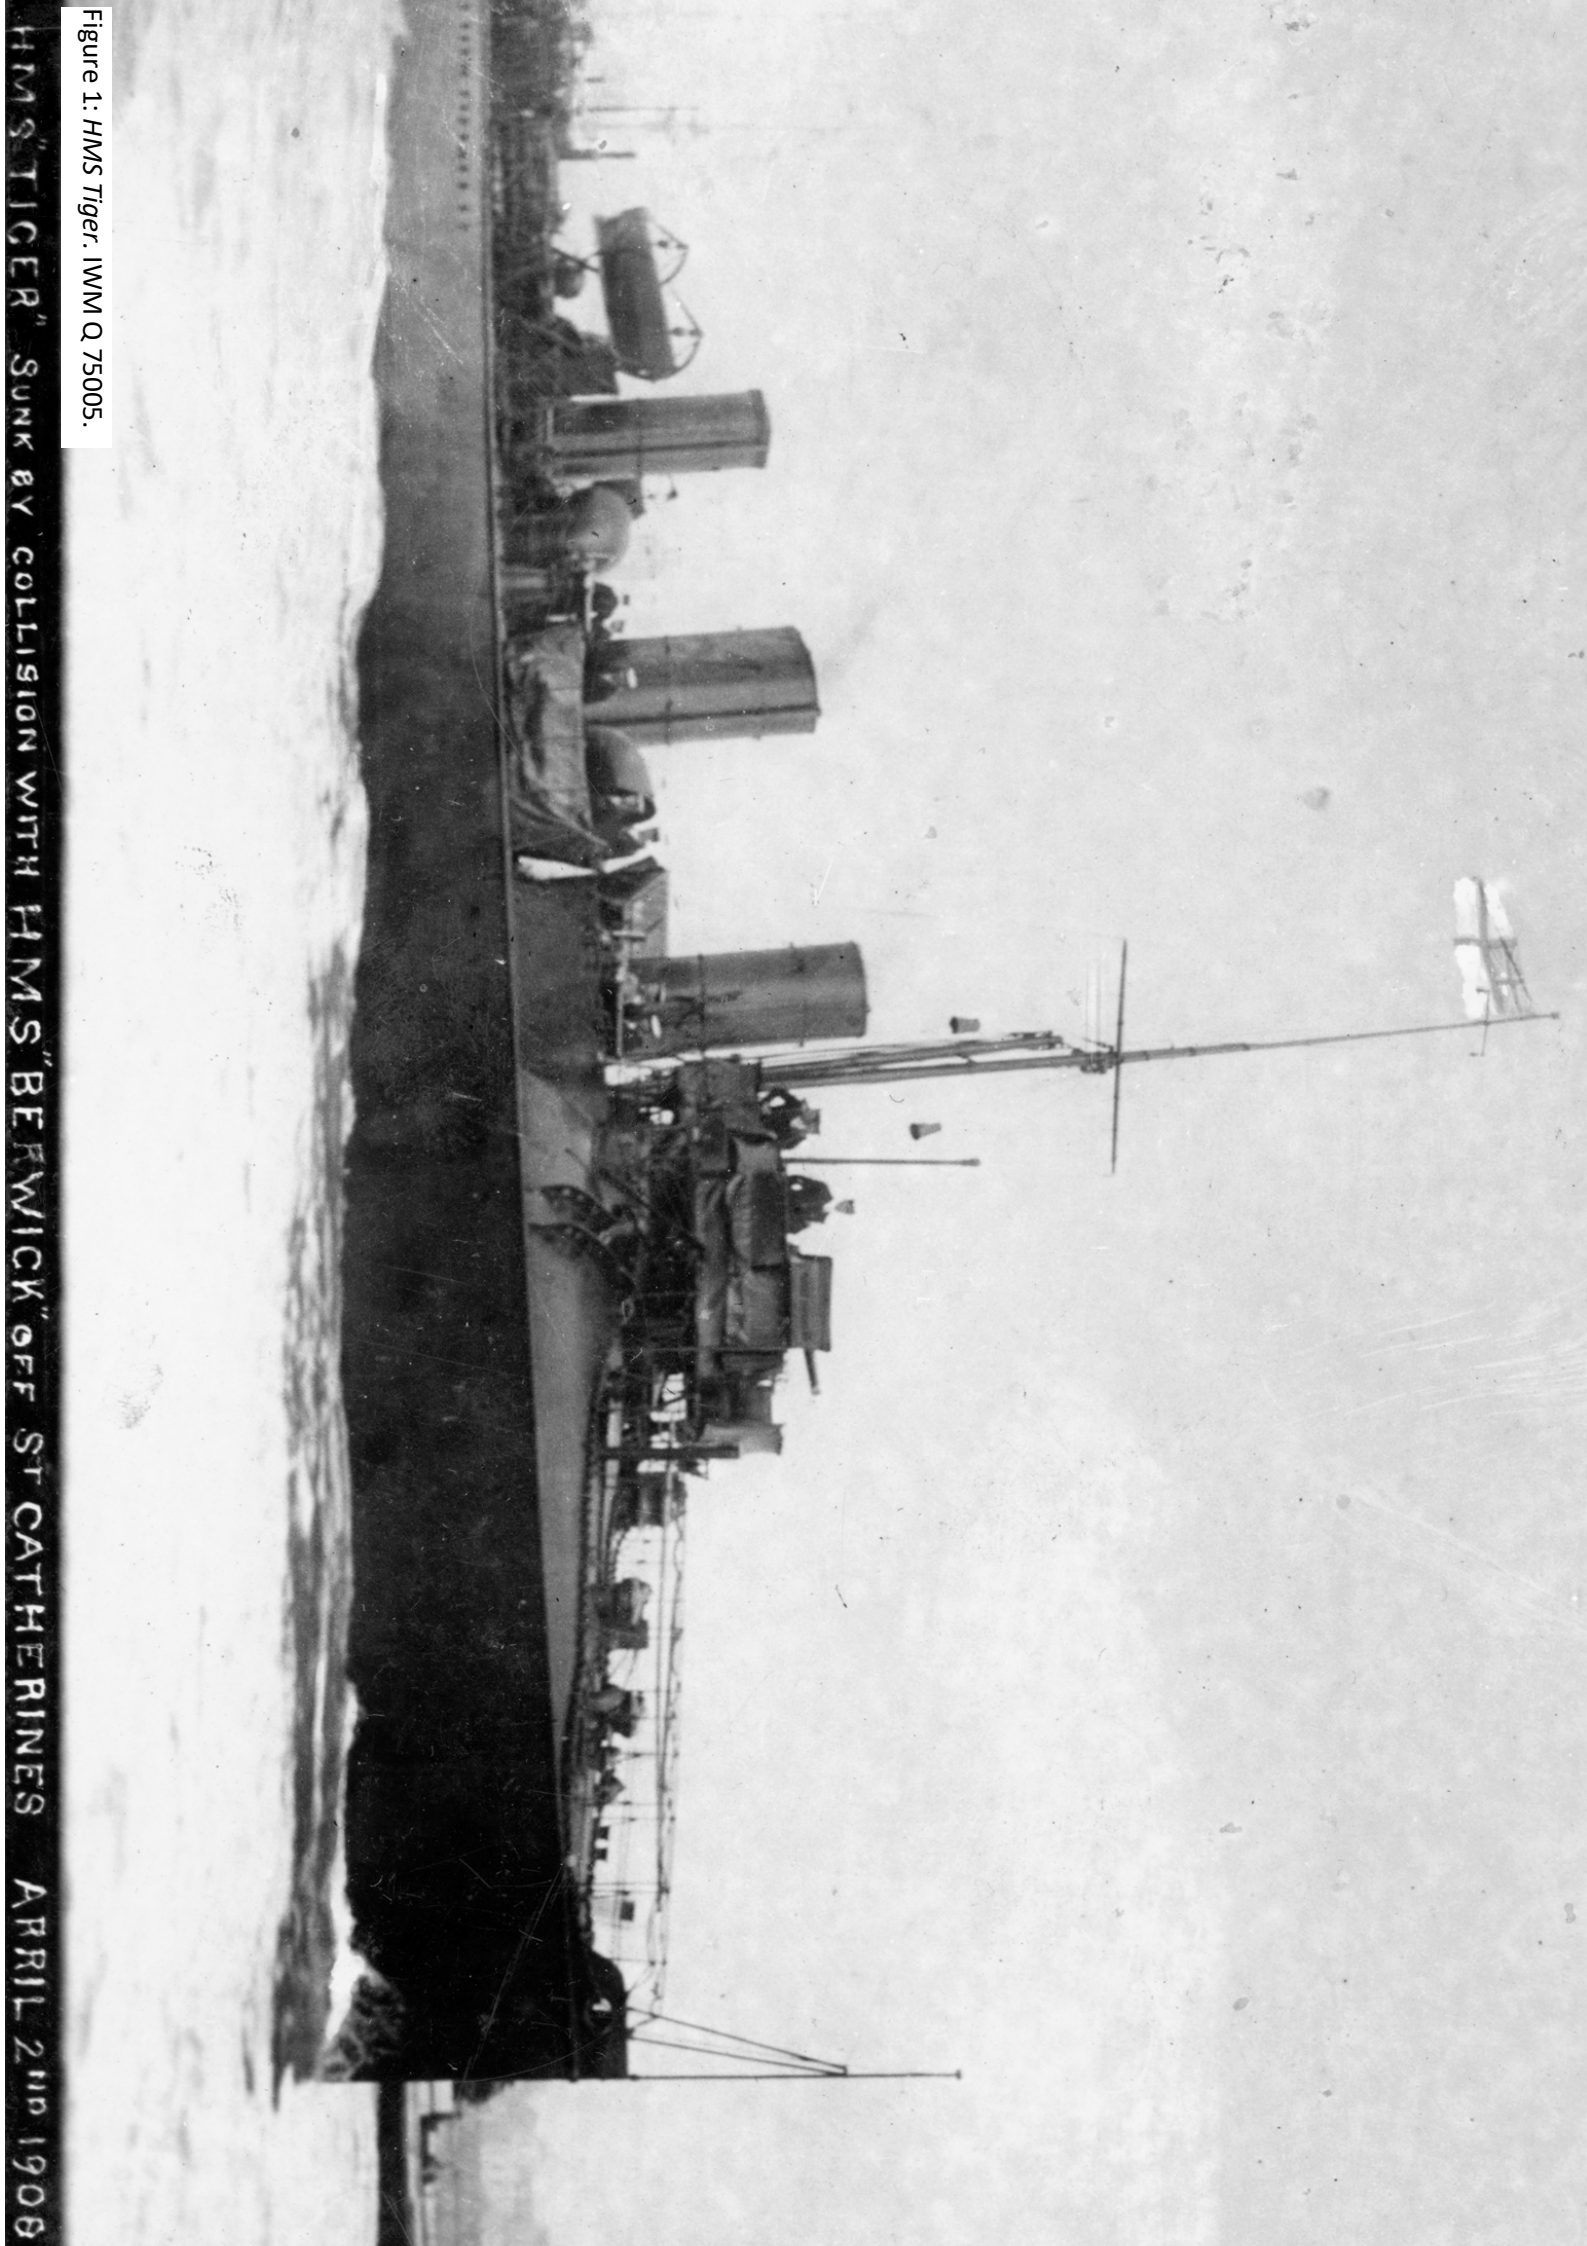
# "Thor". Profile and Plan of Upper Deck as fitted

Profile

Upper Deck

Plan of Yurkle Deck

Documented features include (with reference to numbered compartments on the side profile plan for *Tiger's* sister ship, *HMS Thorn*):

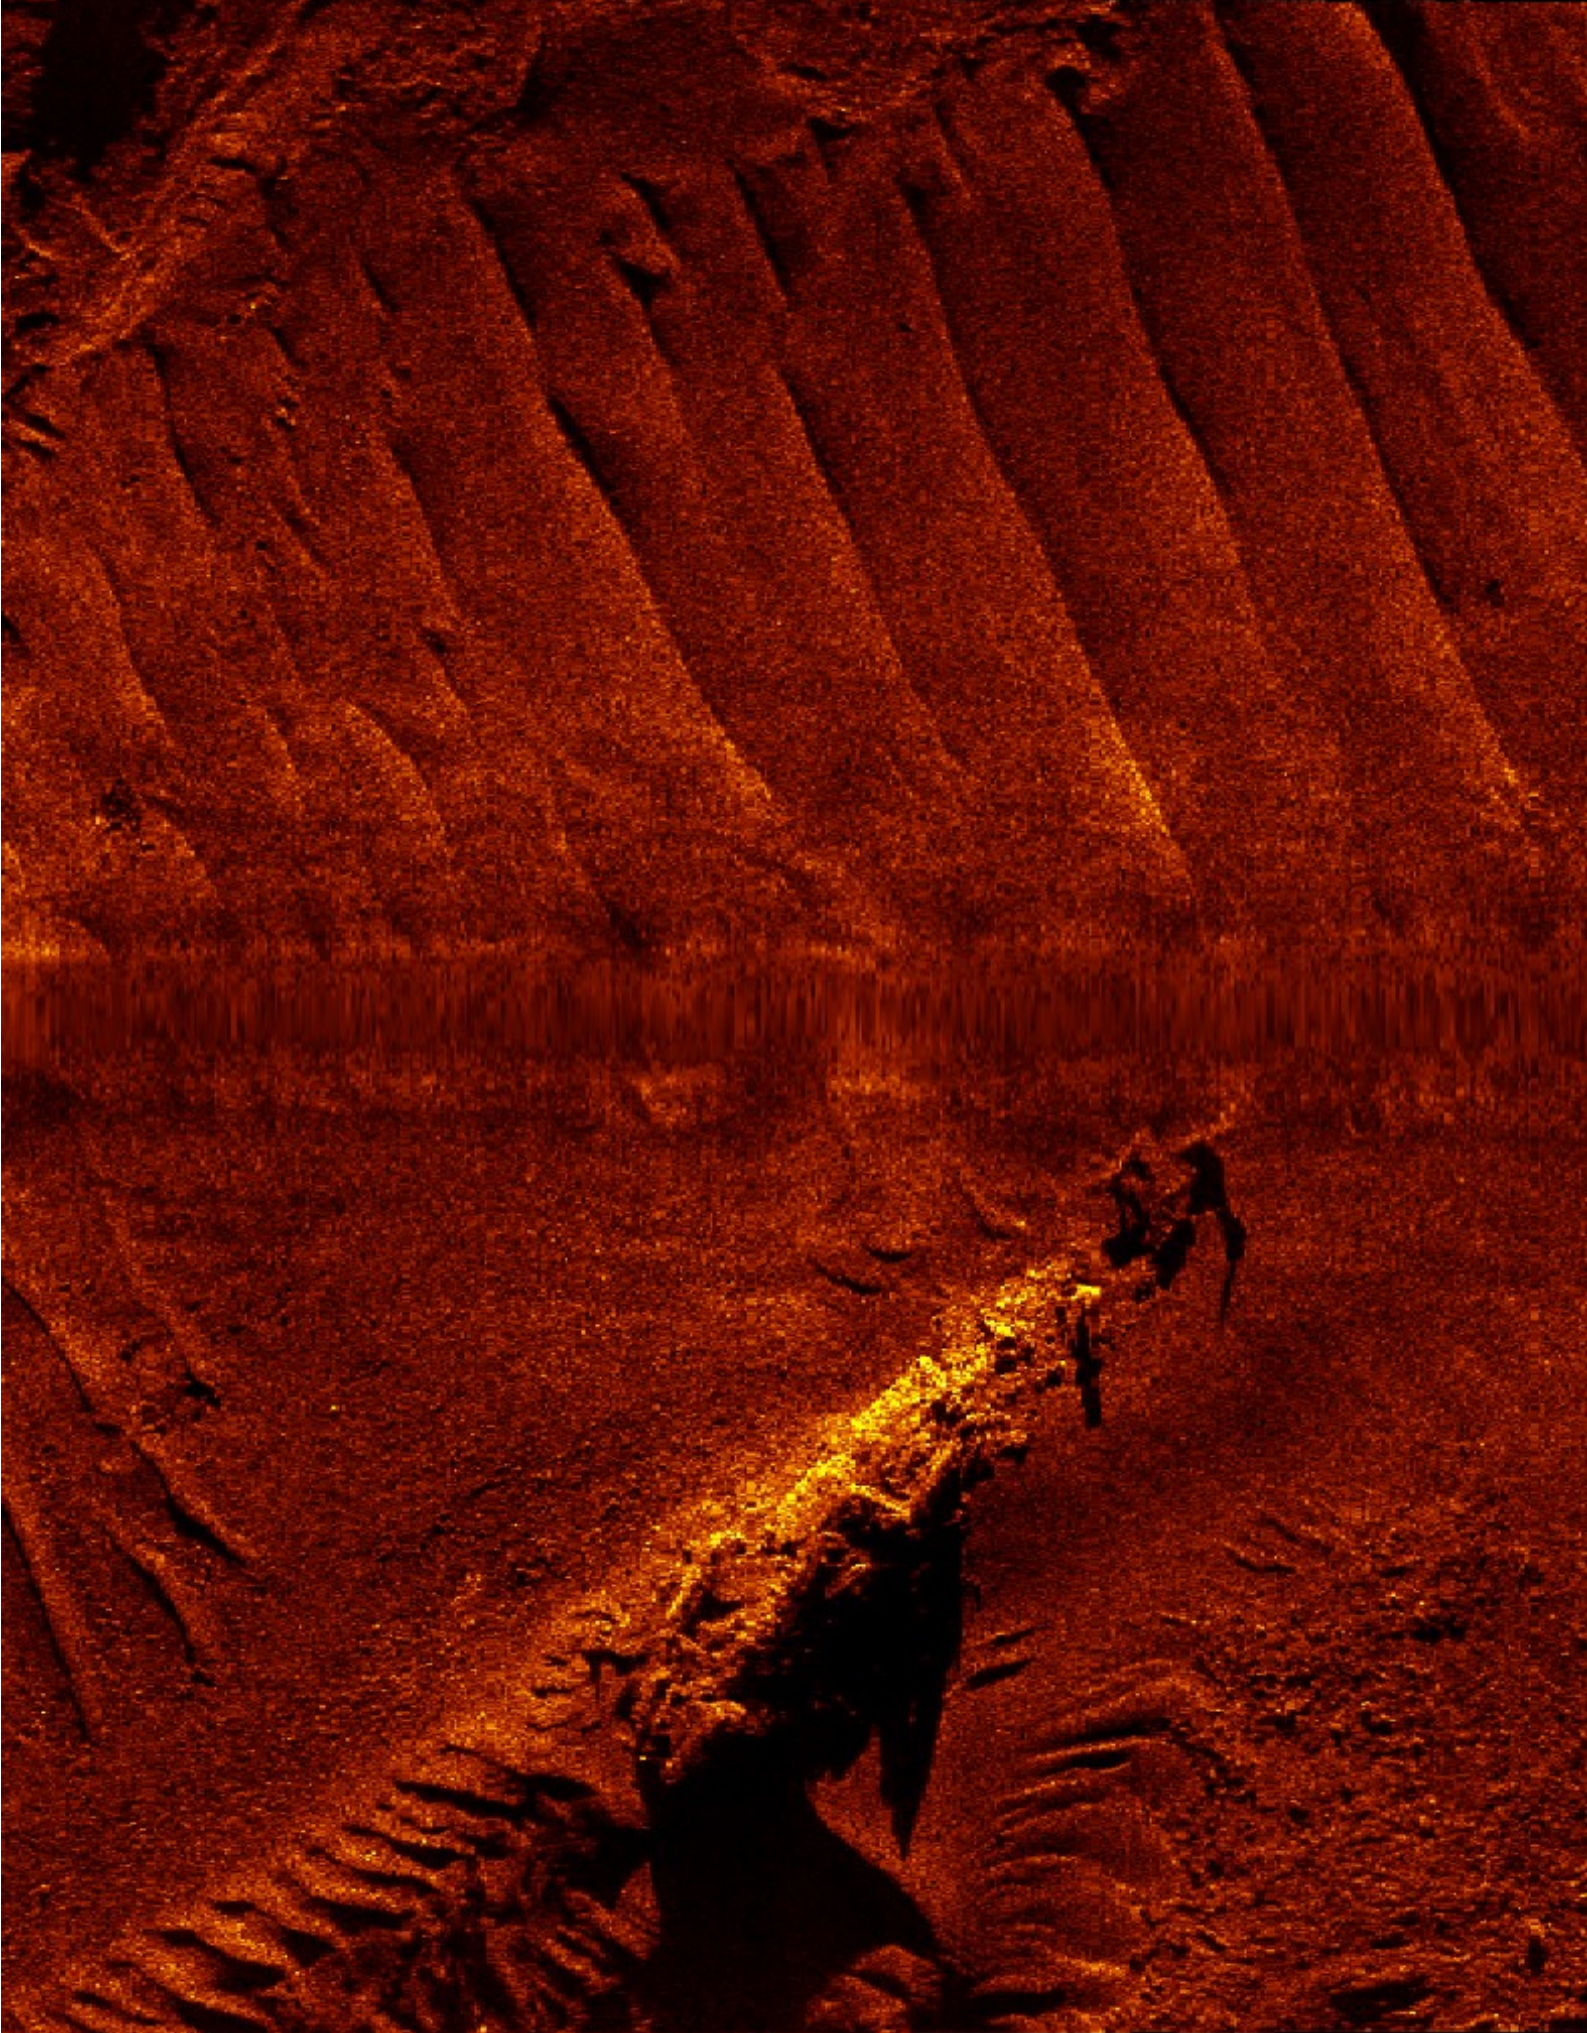
Figure 12 above: Stern section on 780kHz at 37.5m range scanned on 24 July 2026. The horizontal tiller above the well-preserved rudder assembly (top right) casts a long thin shadow on the port side of the wreck. Photo credit: Leo Fielding.

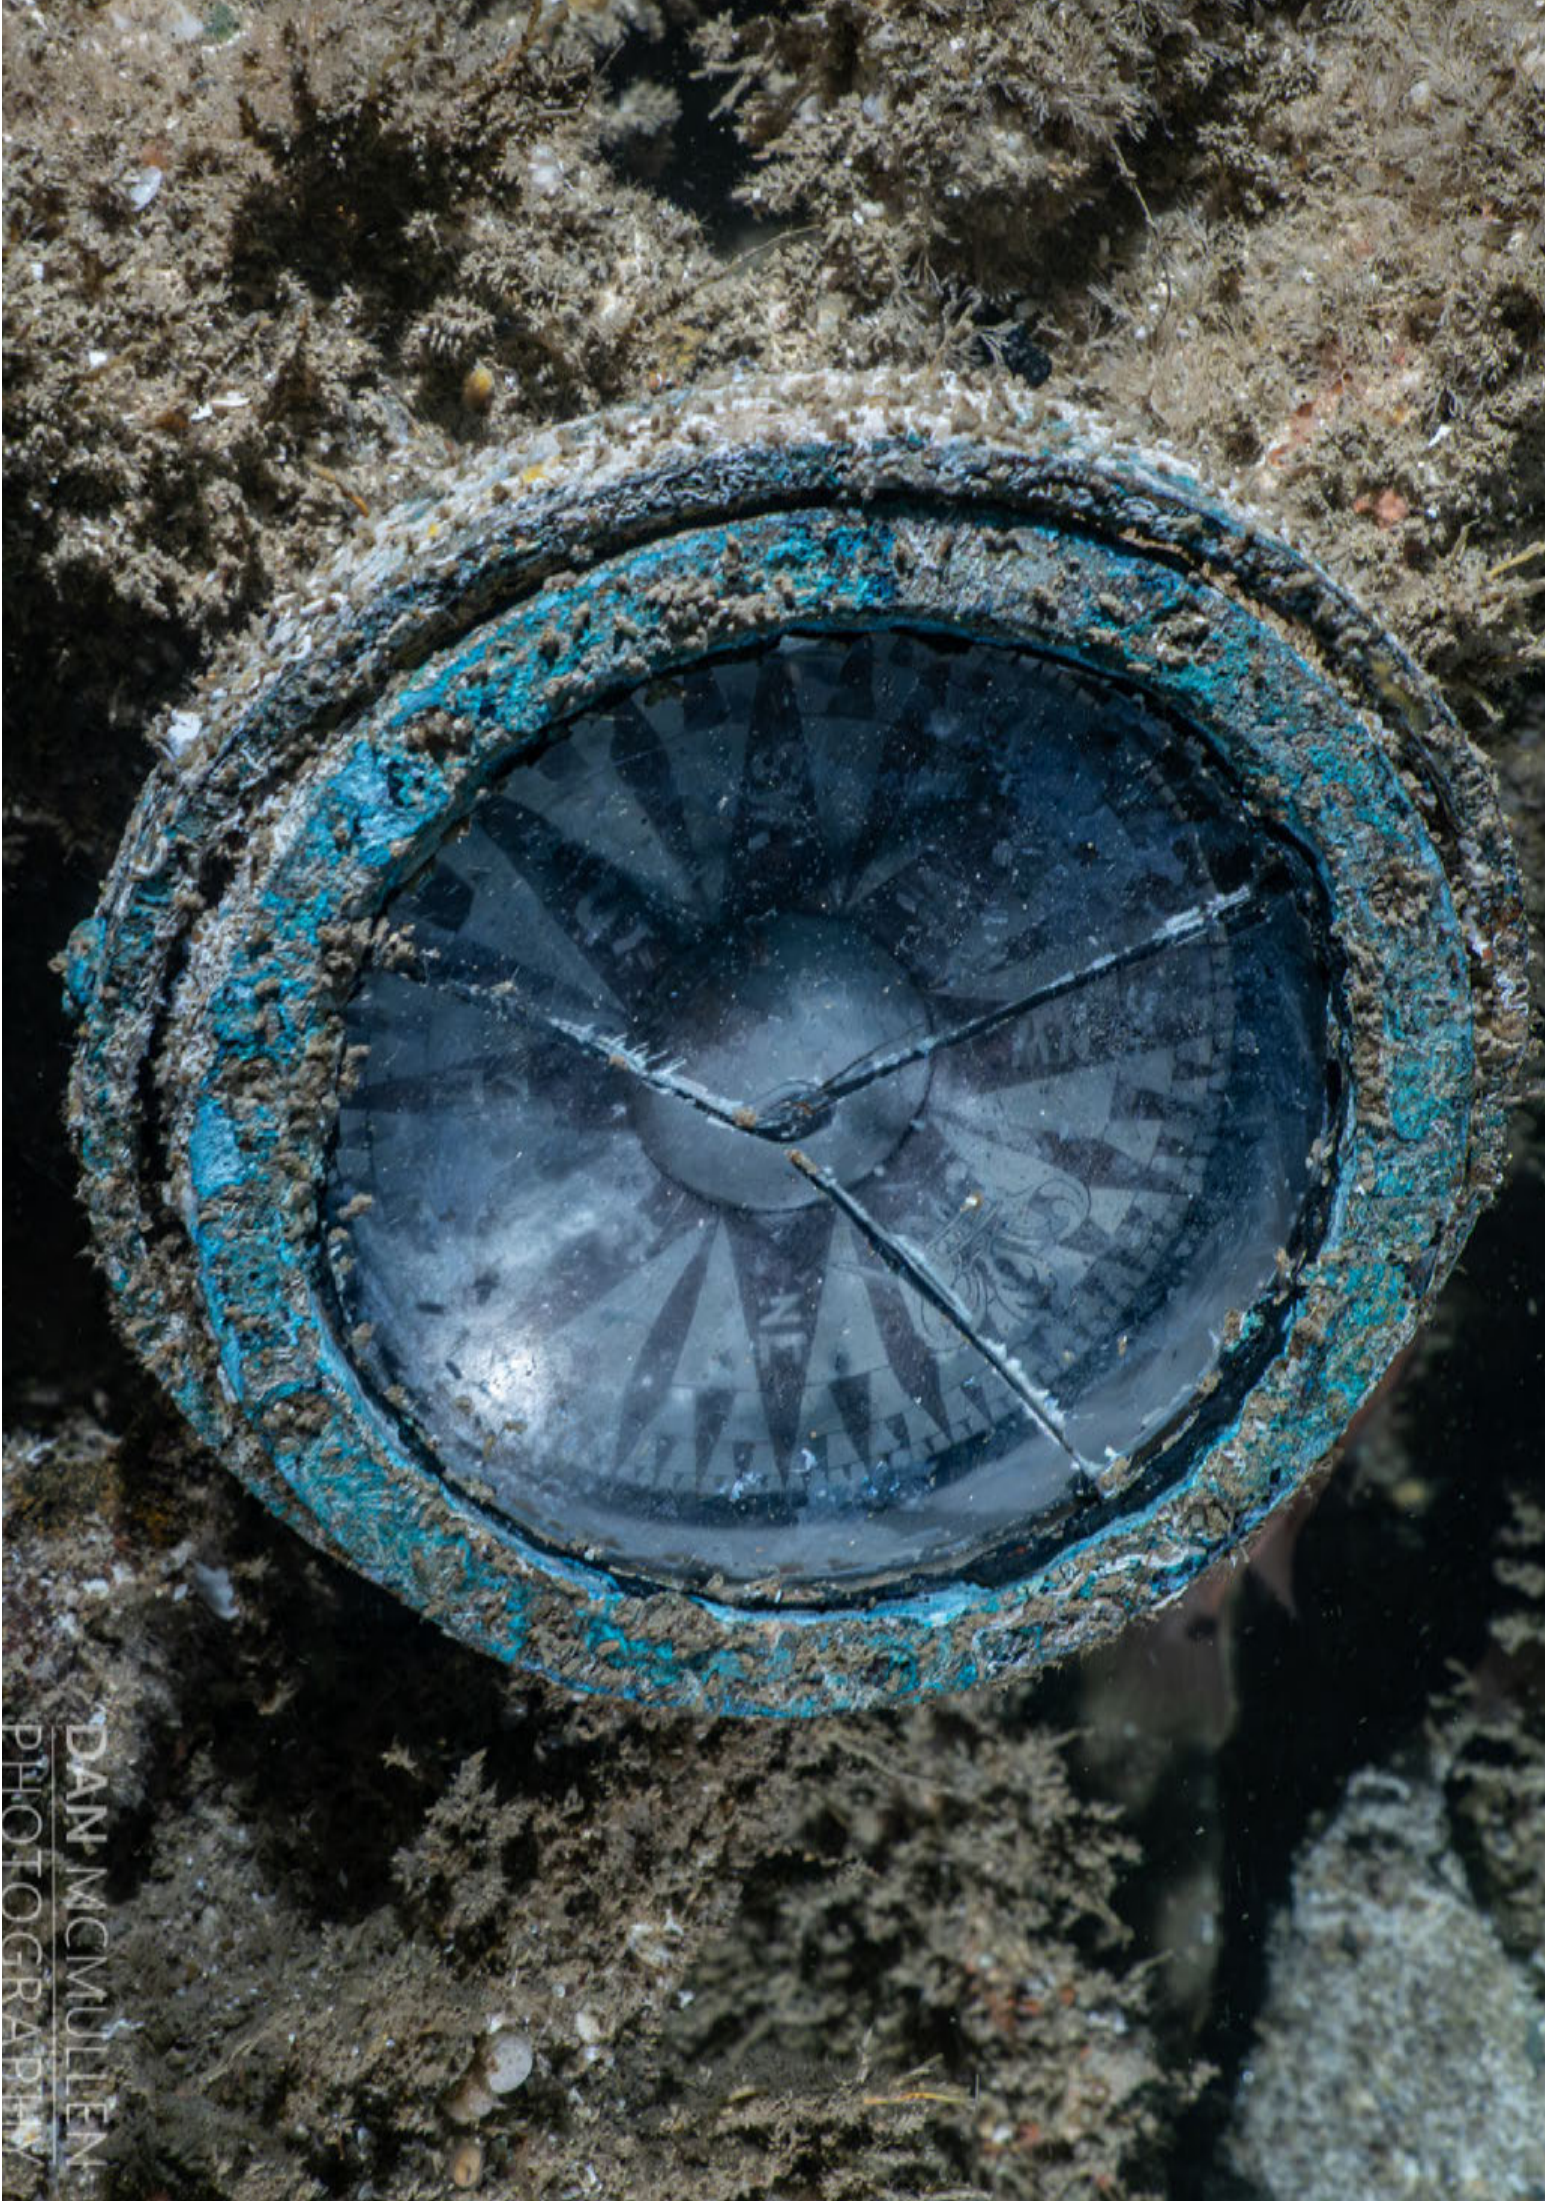
Fluid compass. Near the telegraph, a Dent & Co. London fluid compass with a 128-point graduated card was photographed. The card showed a fleur-de-lis pointing North with “Dent” visible through the glass. Except for a Y-shaped crack across the face of the glass, the glass was otherwise intact. The pattern on the compass is known as pattern 20 and was made exclusively for the Admiralty from 1892 to 1907.

Figure 18: A Dent & Co. London fluid compass with a 128-point graduated card and fleur-de-lis pointing North. Photo credit: Guy Trees.

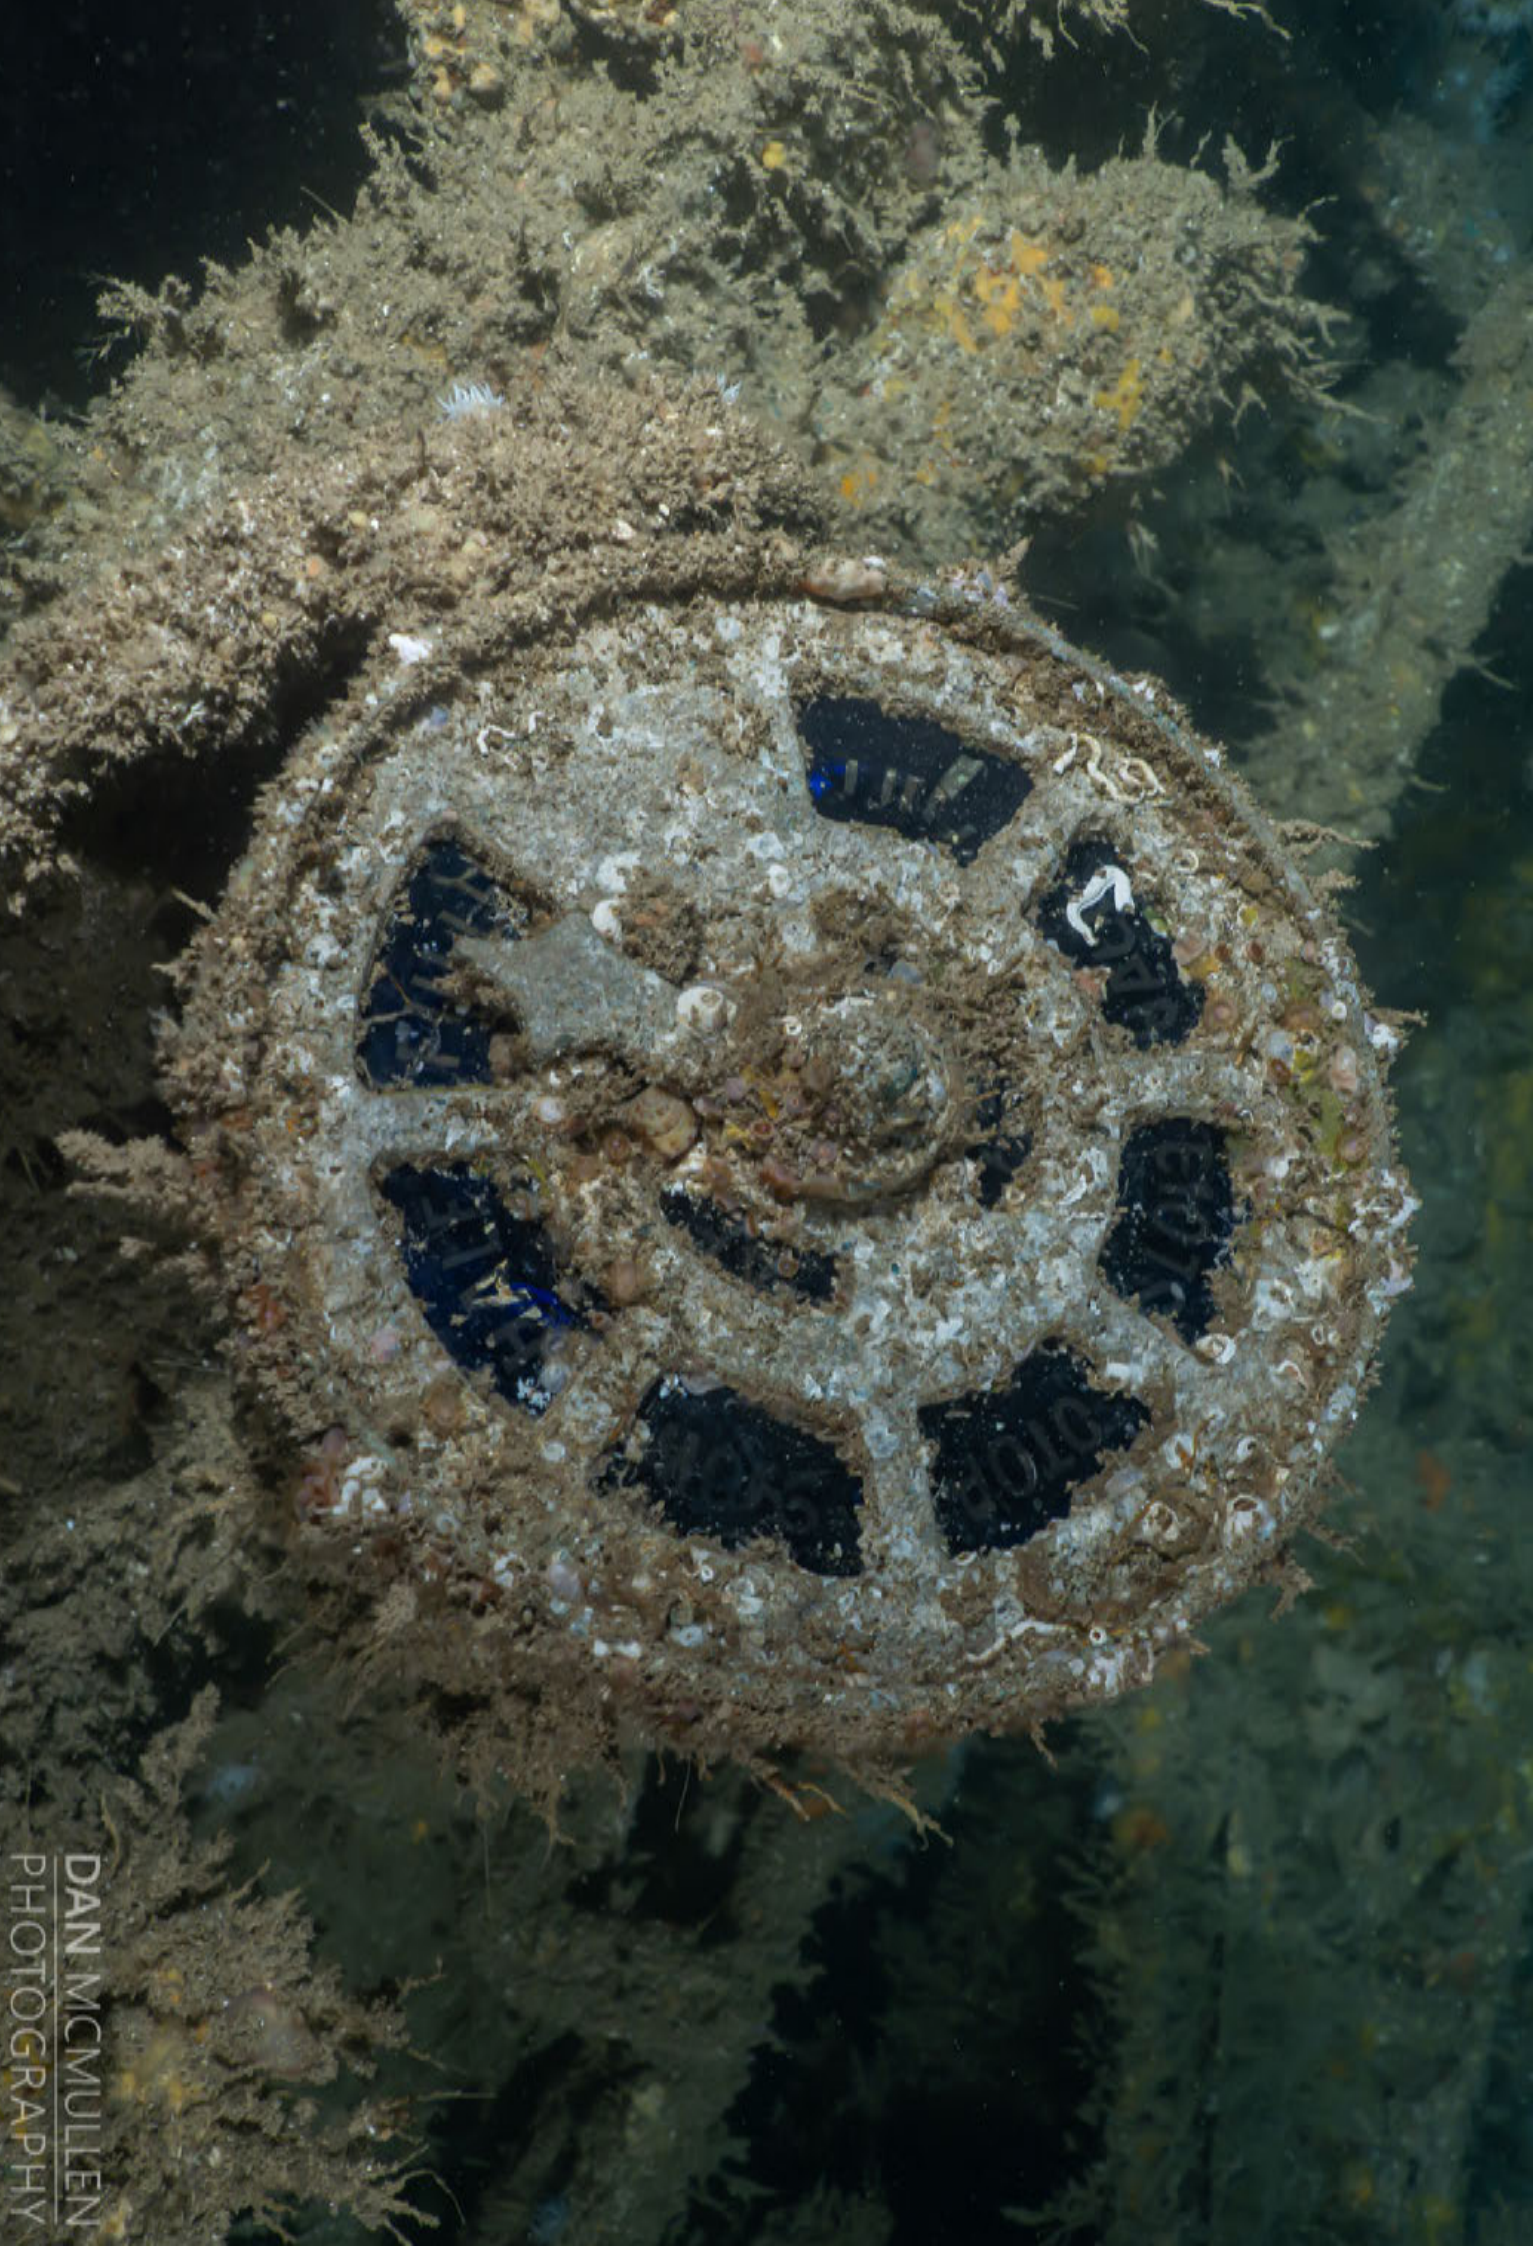
Figure 19: Stern engine revolution telegraph with 7 windows: "Full", "Half", "Slow", "Stop", "Slow", "Half", and "Full". Photo credit: Dan McMullen.

Stern engine revolution telegraph. The stern engine revolution telegraph was photographed. The glass was intact. The face of the dial had 7 windows, each with a sapphire blue background, with white lettering in capital letters, stating “Full”, “Half”, “Slow”, “Stop”, “Slow”, “Half”, and “Full”. The indicating arrow on the face of the dial was still showing “Full”. This confirmed our first major factual finding about the events of 2 April 1908, namely that *Tiger* had not reduced speed to avoid collision with *Berwick*.

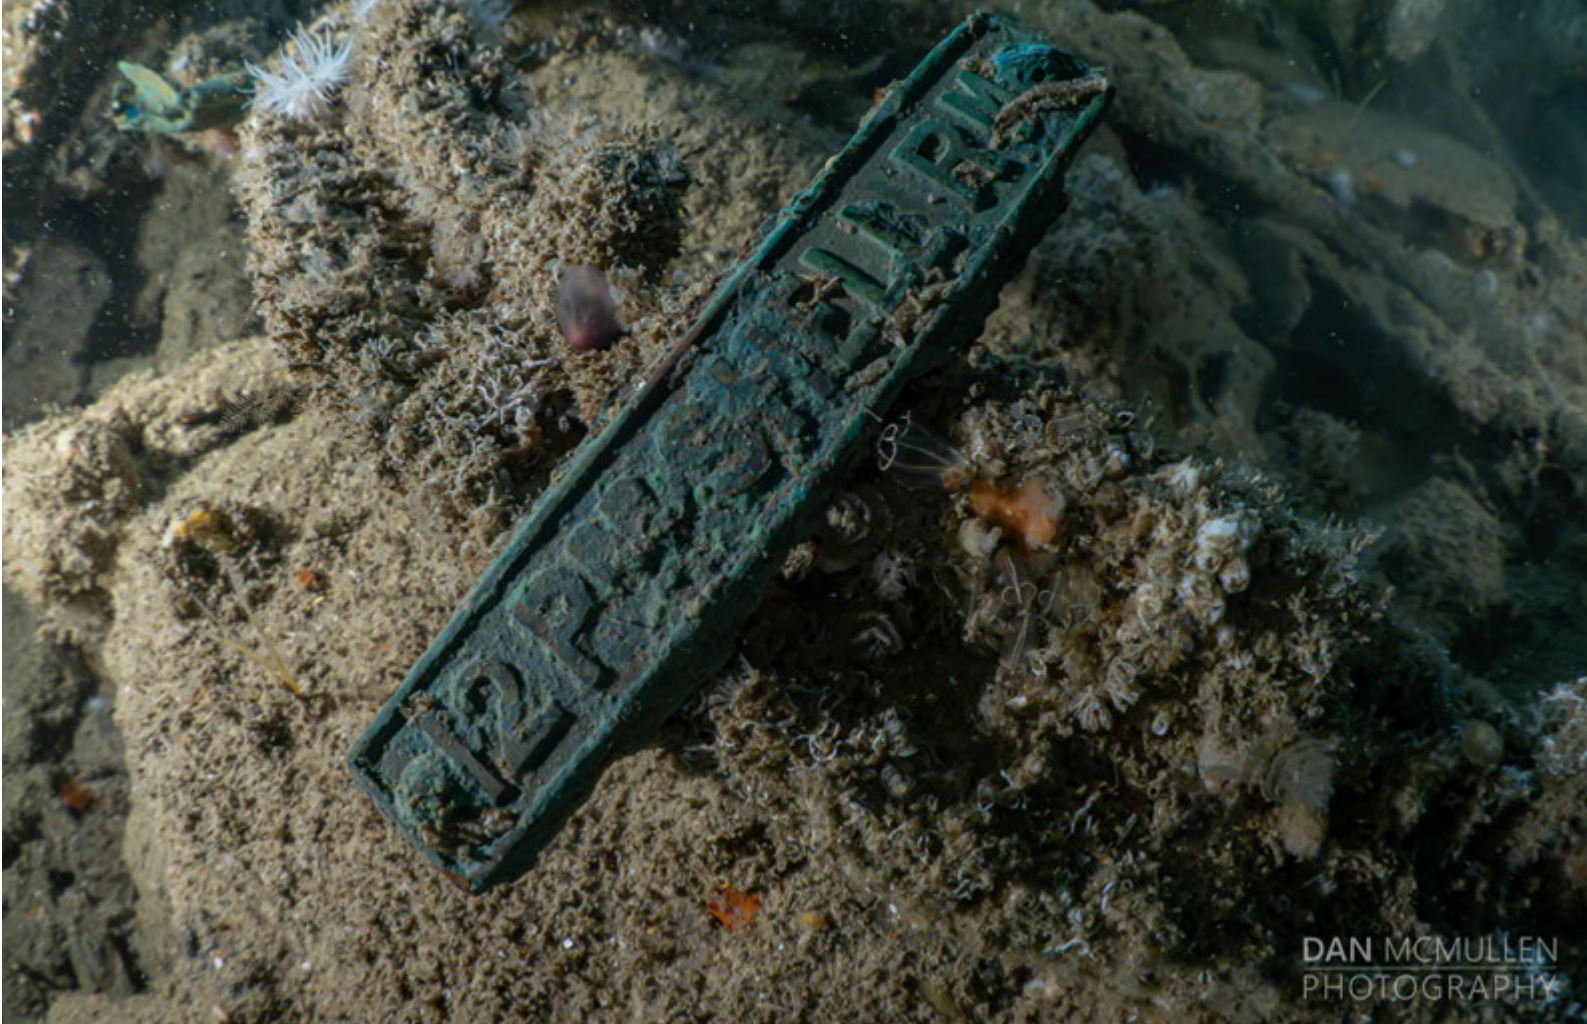
Figures 22 and 23: The team located a brass rectangular cast-metal plaque with raised lettering marked: "12 PDR SHELL RM". Photo credit: Dan McMullen.

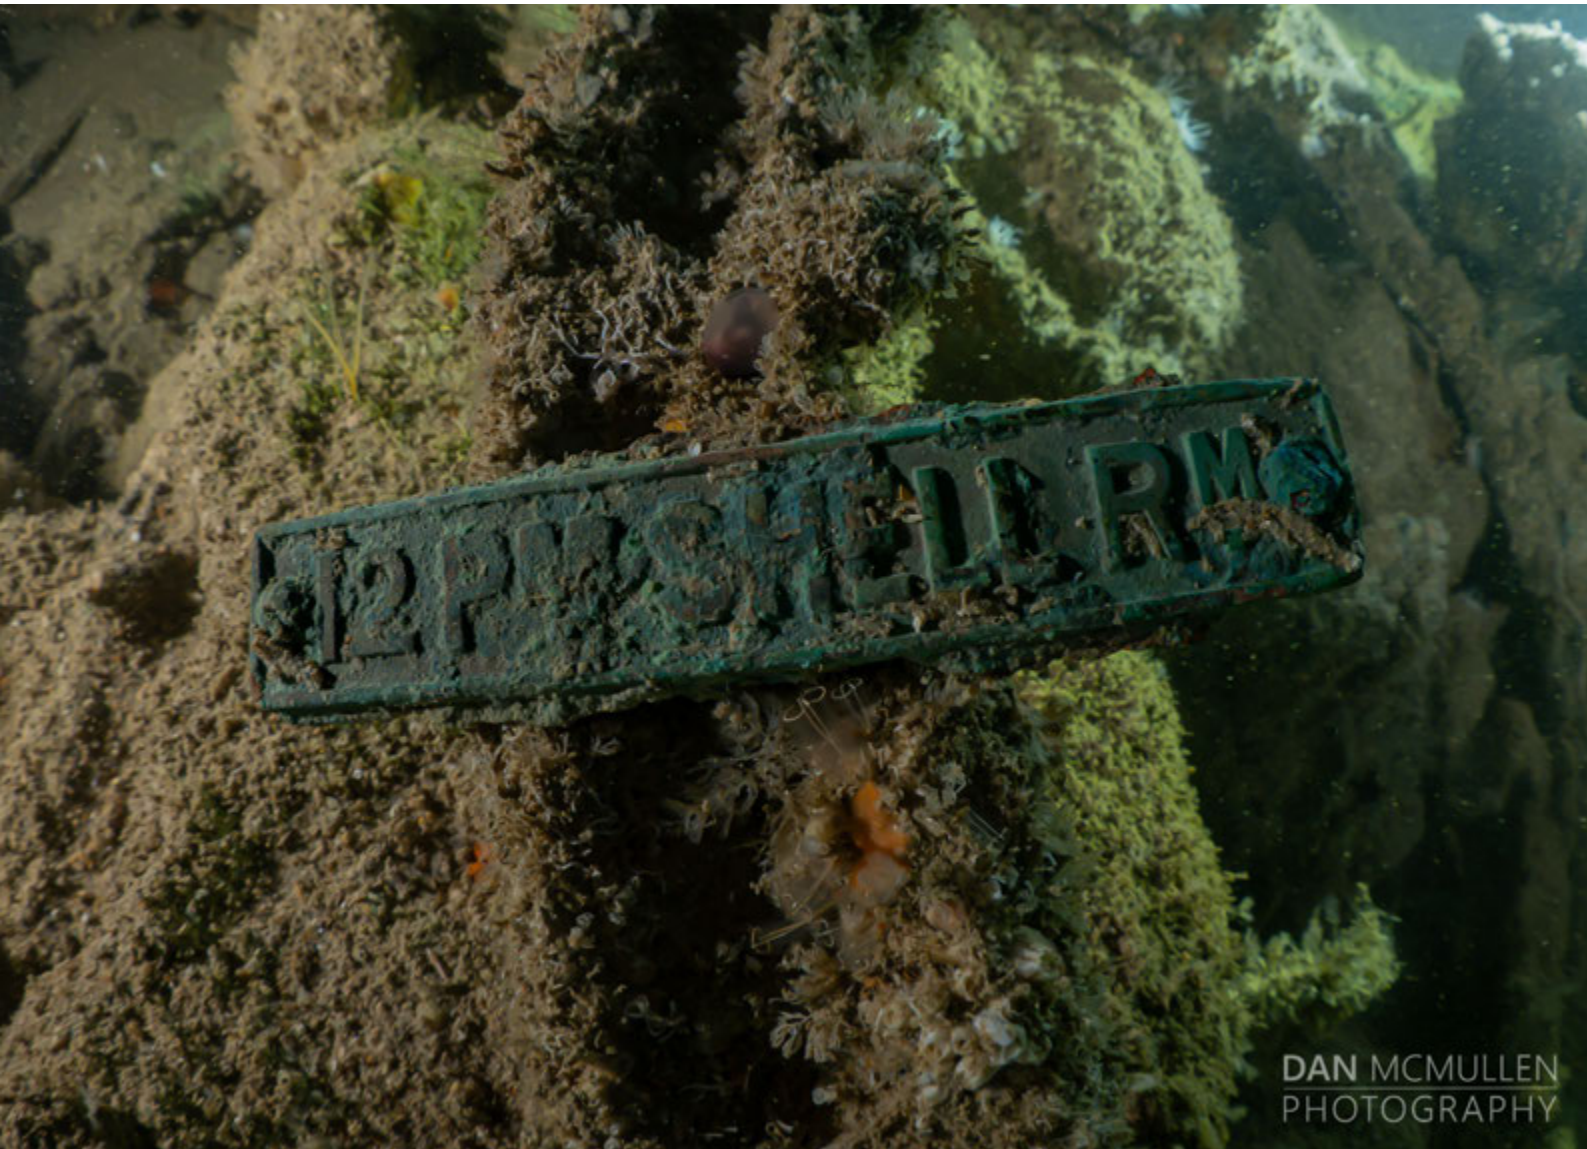
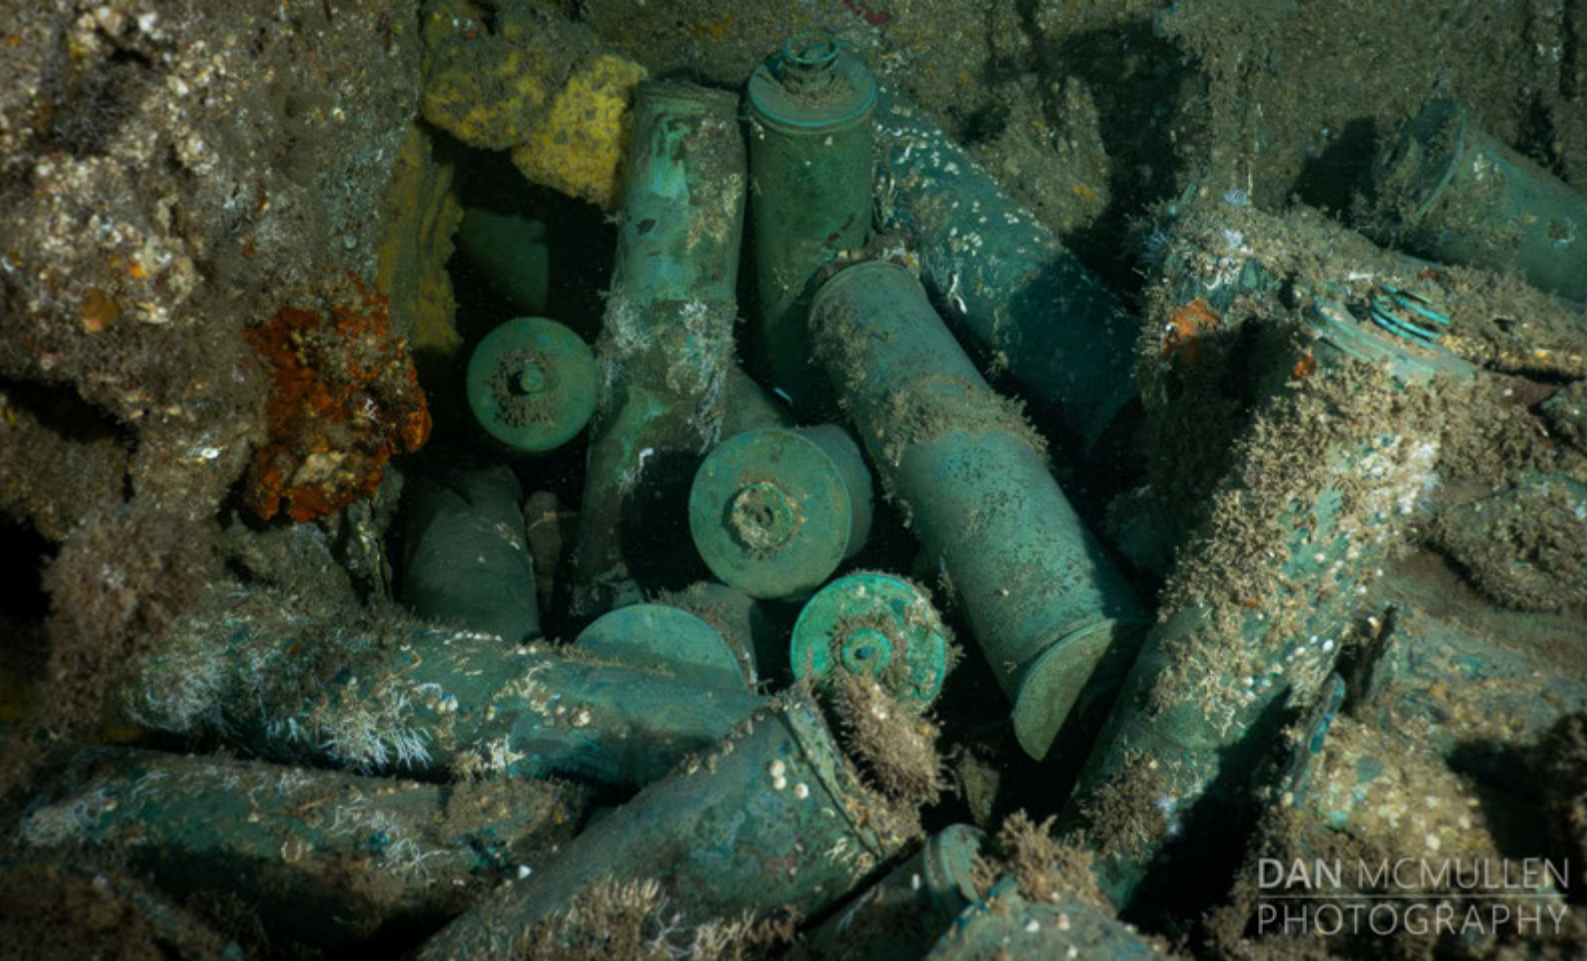
Figures 24 and 25: Racks of cartridge cases on the bow section complete with primers and springs for the 12-pdr. gun. The rim diameter at the primer end was measured to be approximately 100mm (3.9 inches). Photo credit: Dan McMullen.

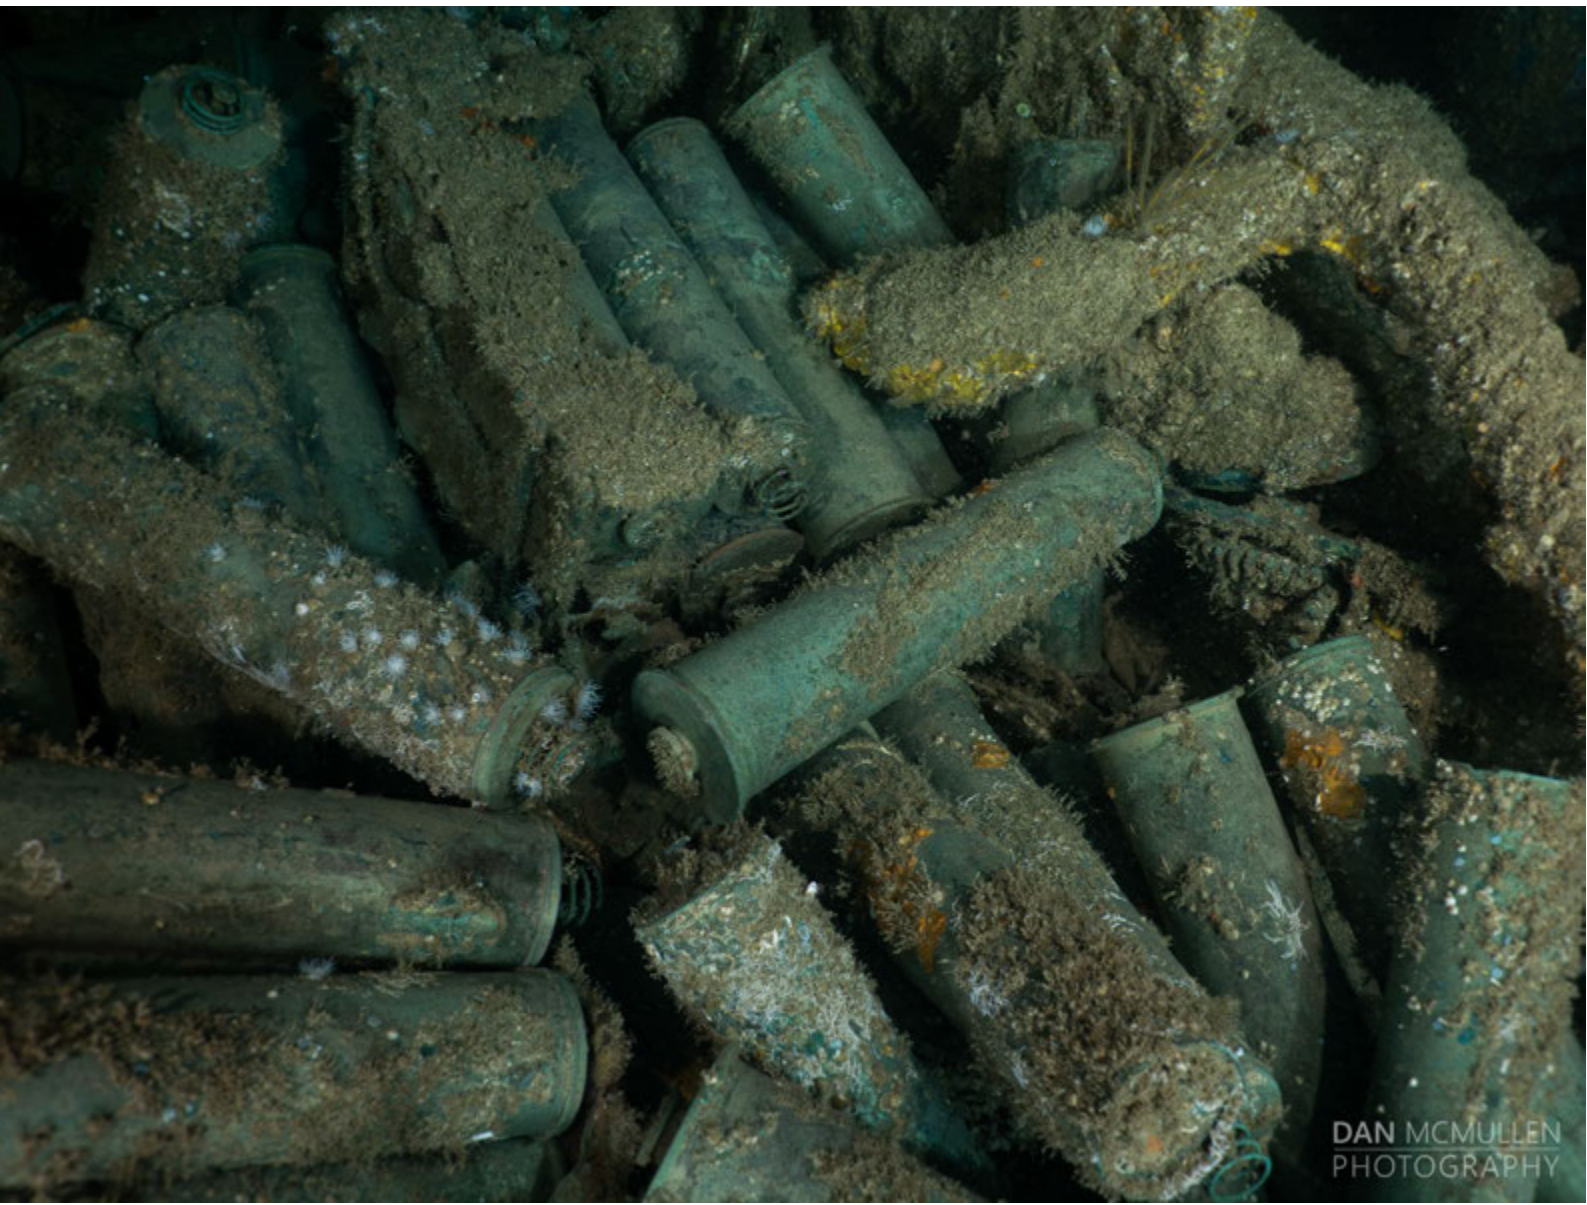
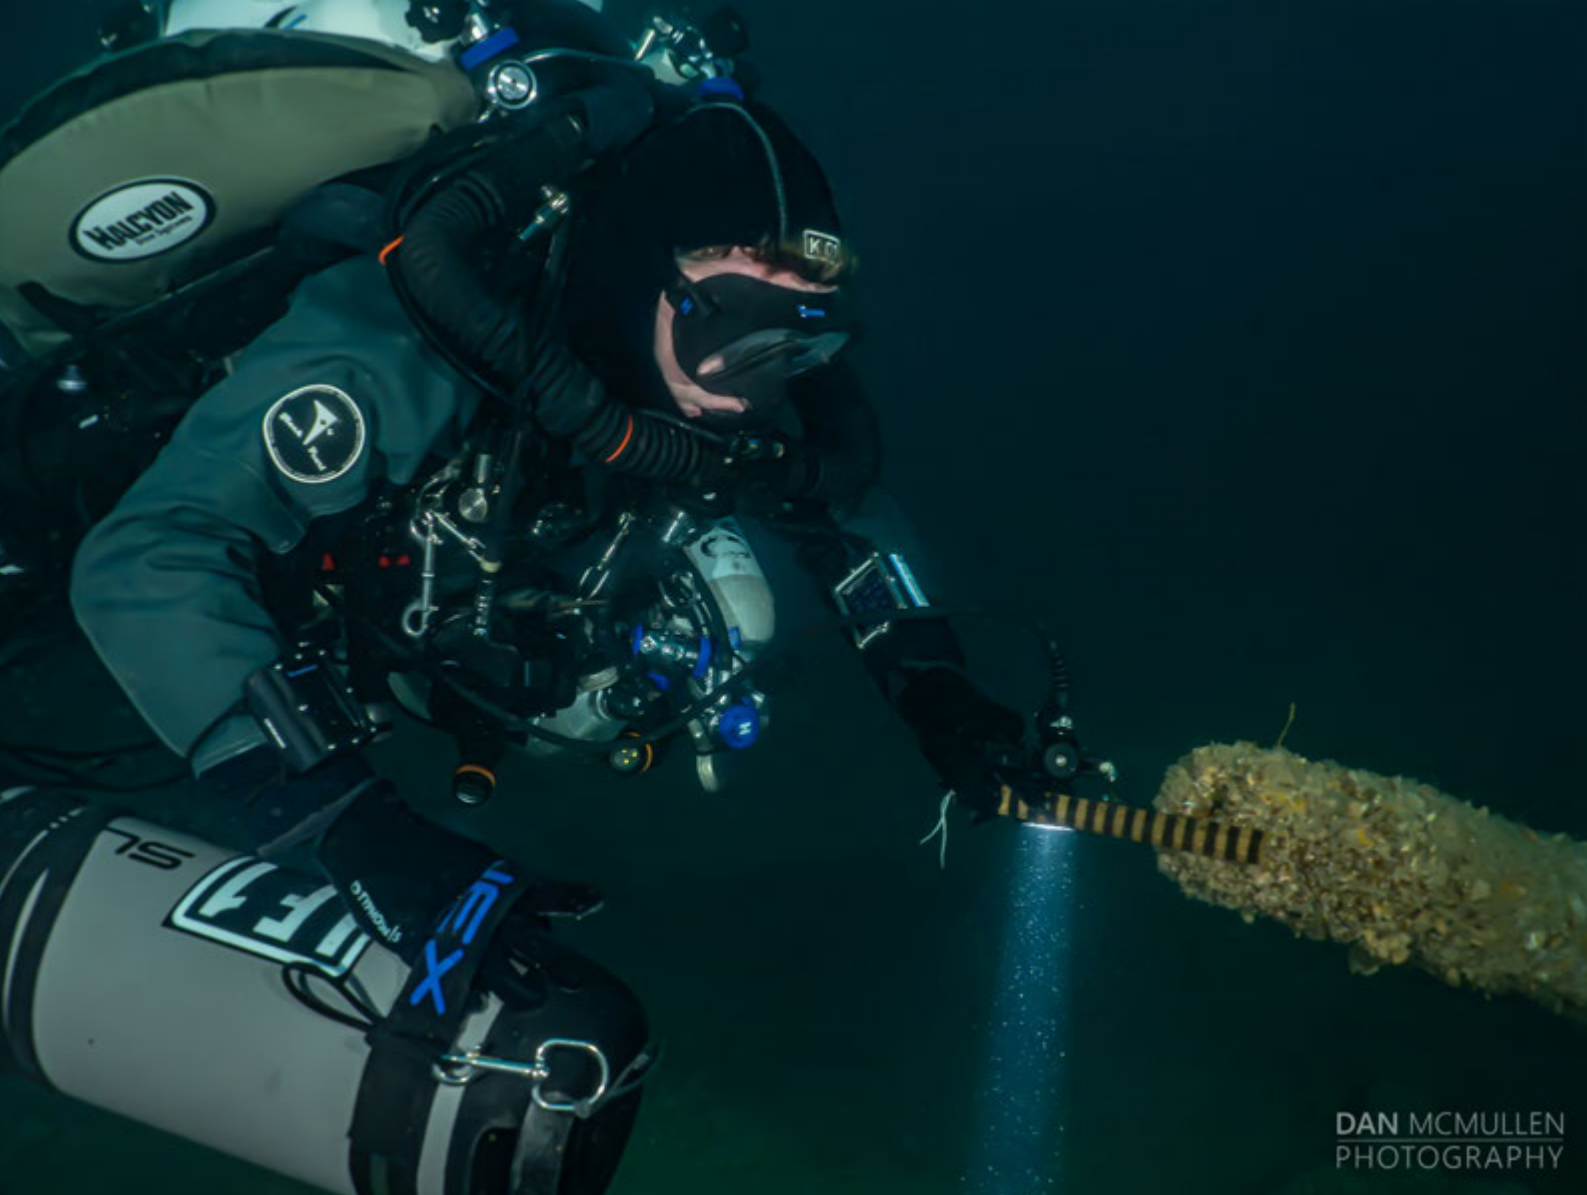
Figures 26 and 27: On the starboard side of the bow, there was a 6-pdr. gun upside down with the barrel pointing diagonally on the seabed. Leo Fielding measured the internal barrel diameter at the muzzle to be 57mm (2.2 inches). Photo credit: Dan McMullen.
