# *The discovery of HMS Tiger* **The last 30-knotter** 10 August 2026

*This report outlines the discovery, identification and documentation of HMS Tiger, the last missing British 30-knot torpedo boat destroyer sunk in the English Channel, cut in two by a collision with the 9,800-tonne armoured cruiser HMS Berwick during night manoeuvres on 2 April 1908.*

**Project co-organised by Leo Fielding and Dan McMullen**

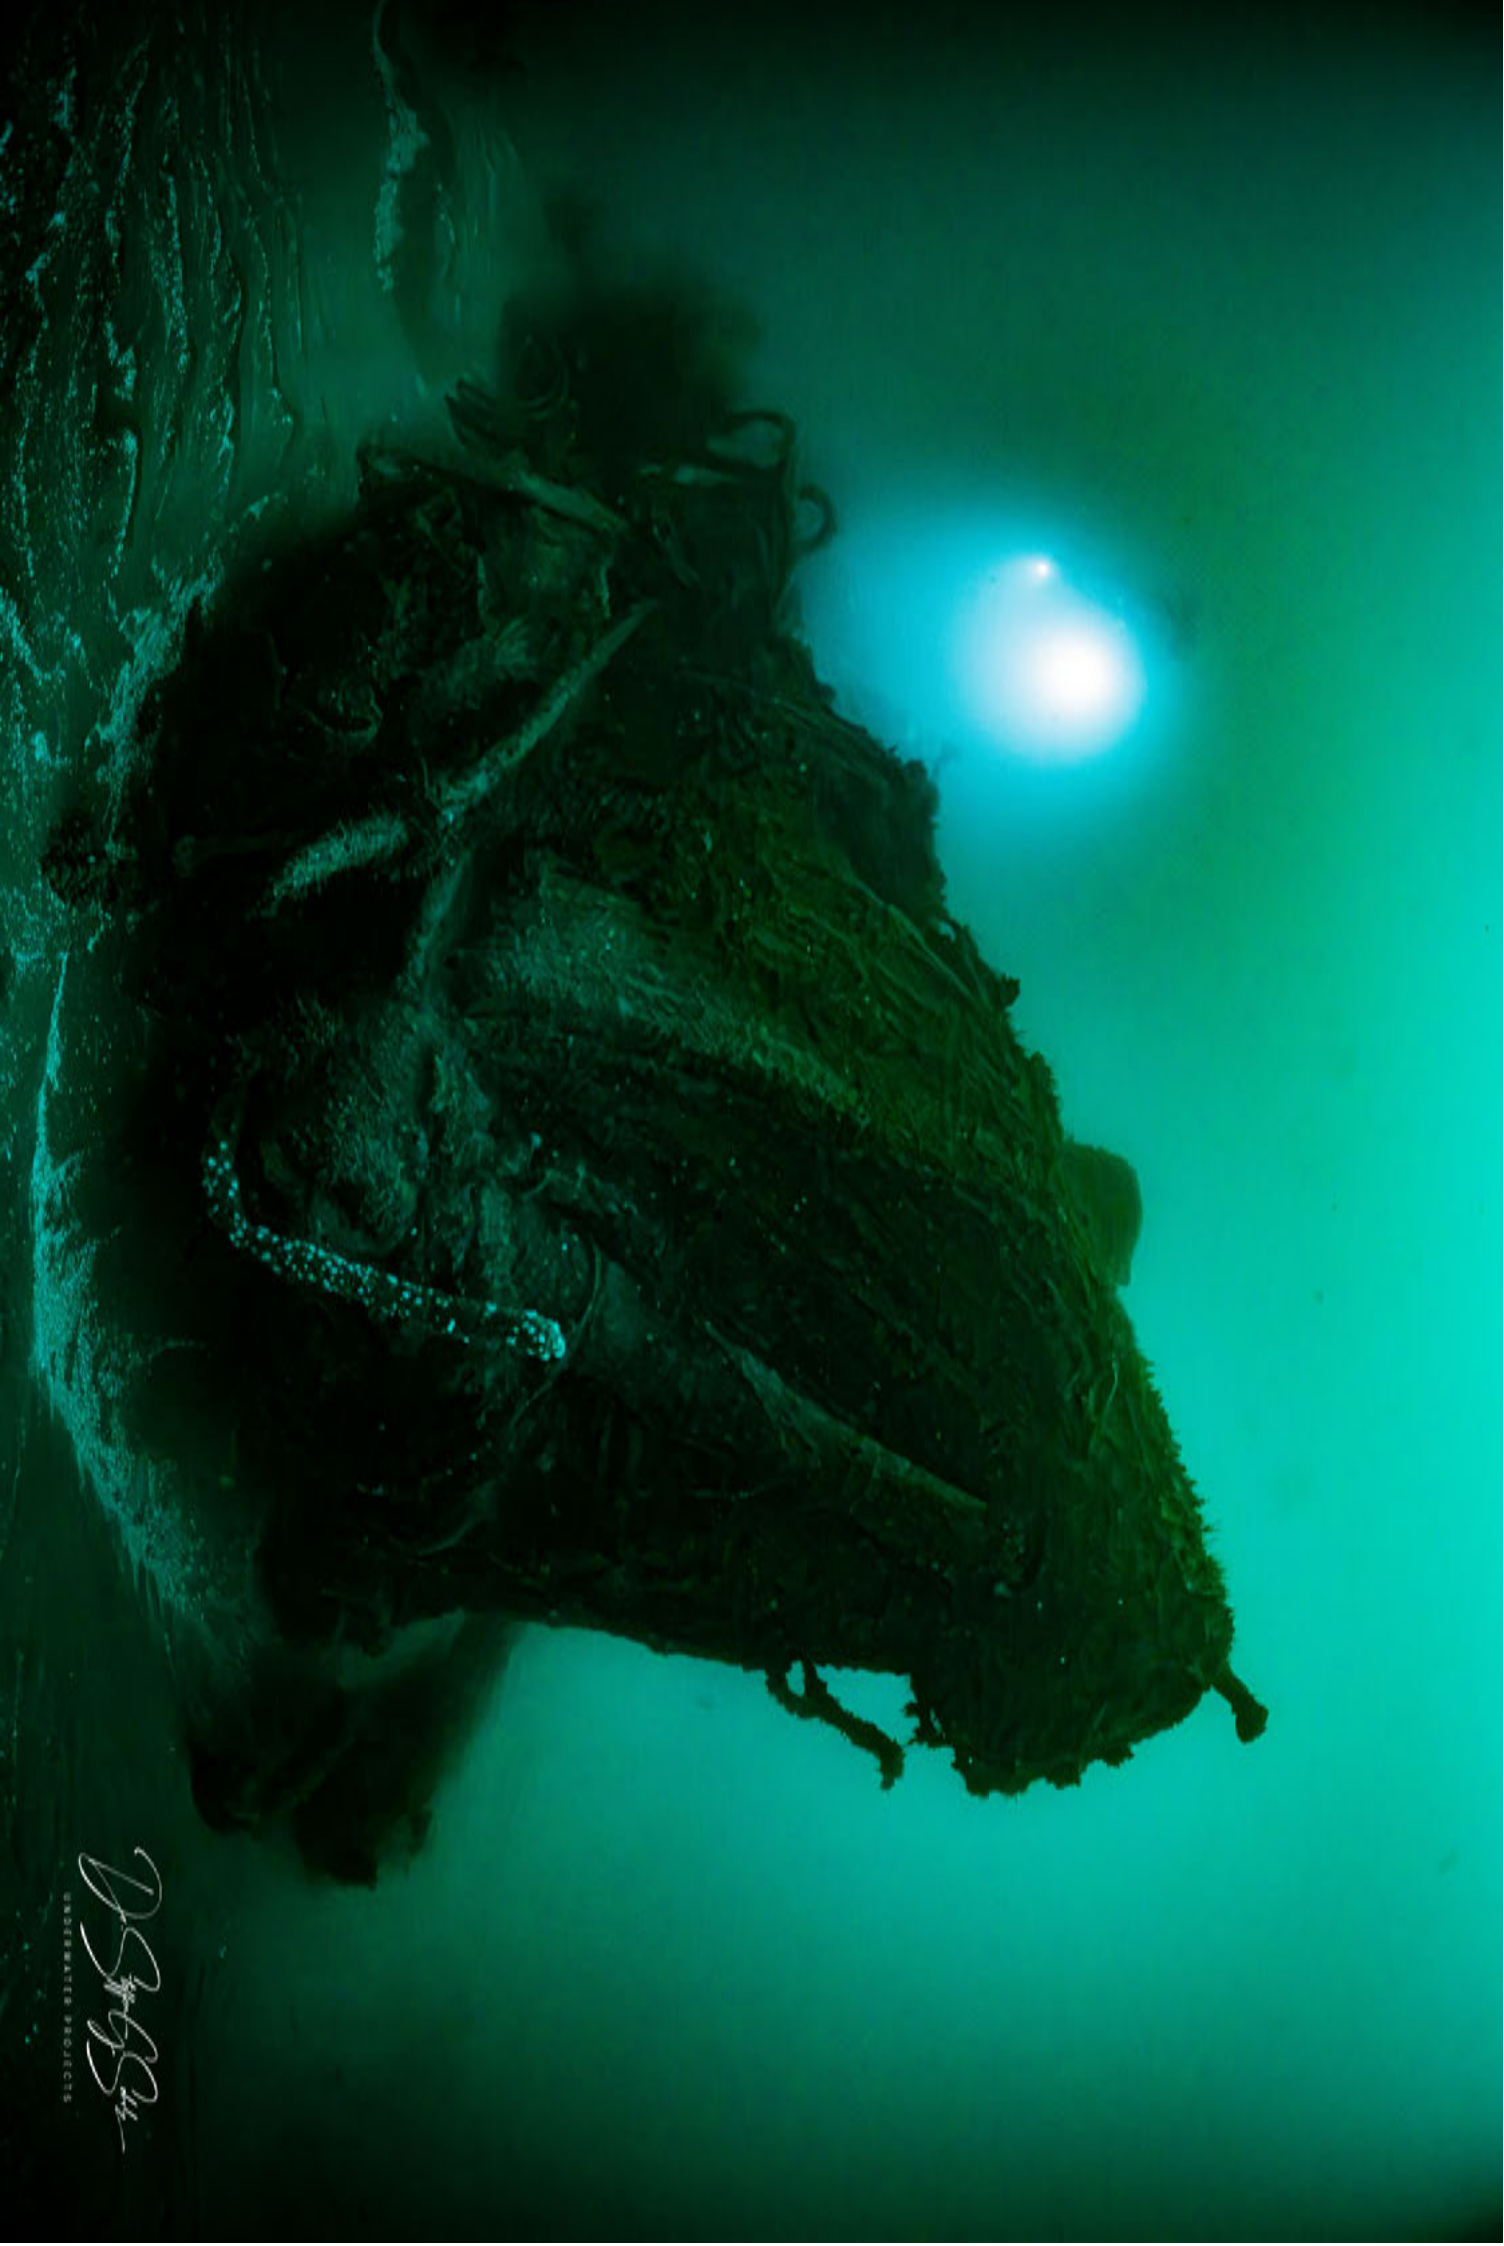
Figure 28: The 4<sup>th</sup> of the 4 “Normand” boilers located on the stern section. Here, the wreck was cut in a relatively clean cross-section such that it was possible to see clearly inside the hull.

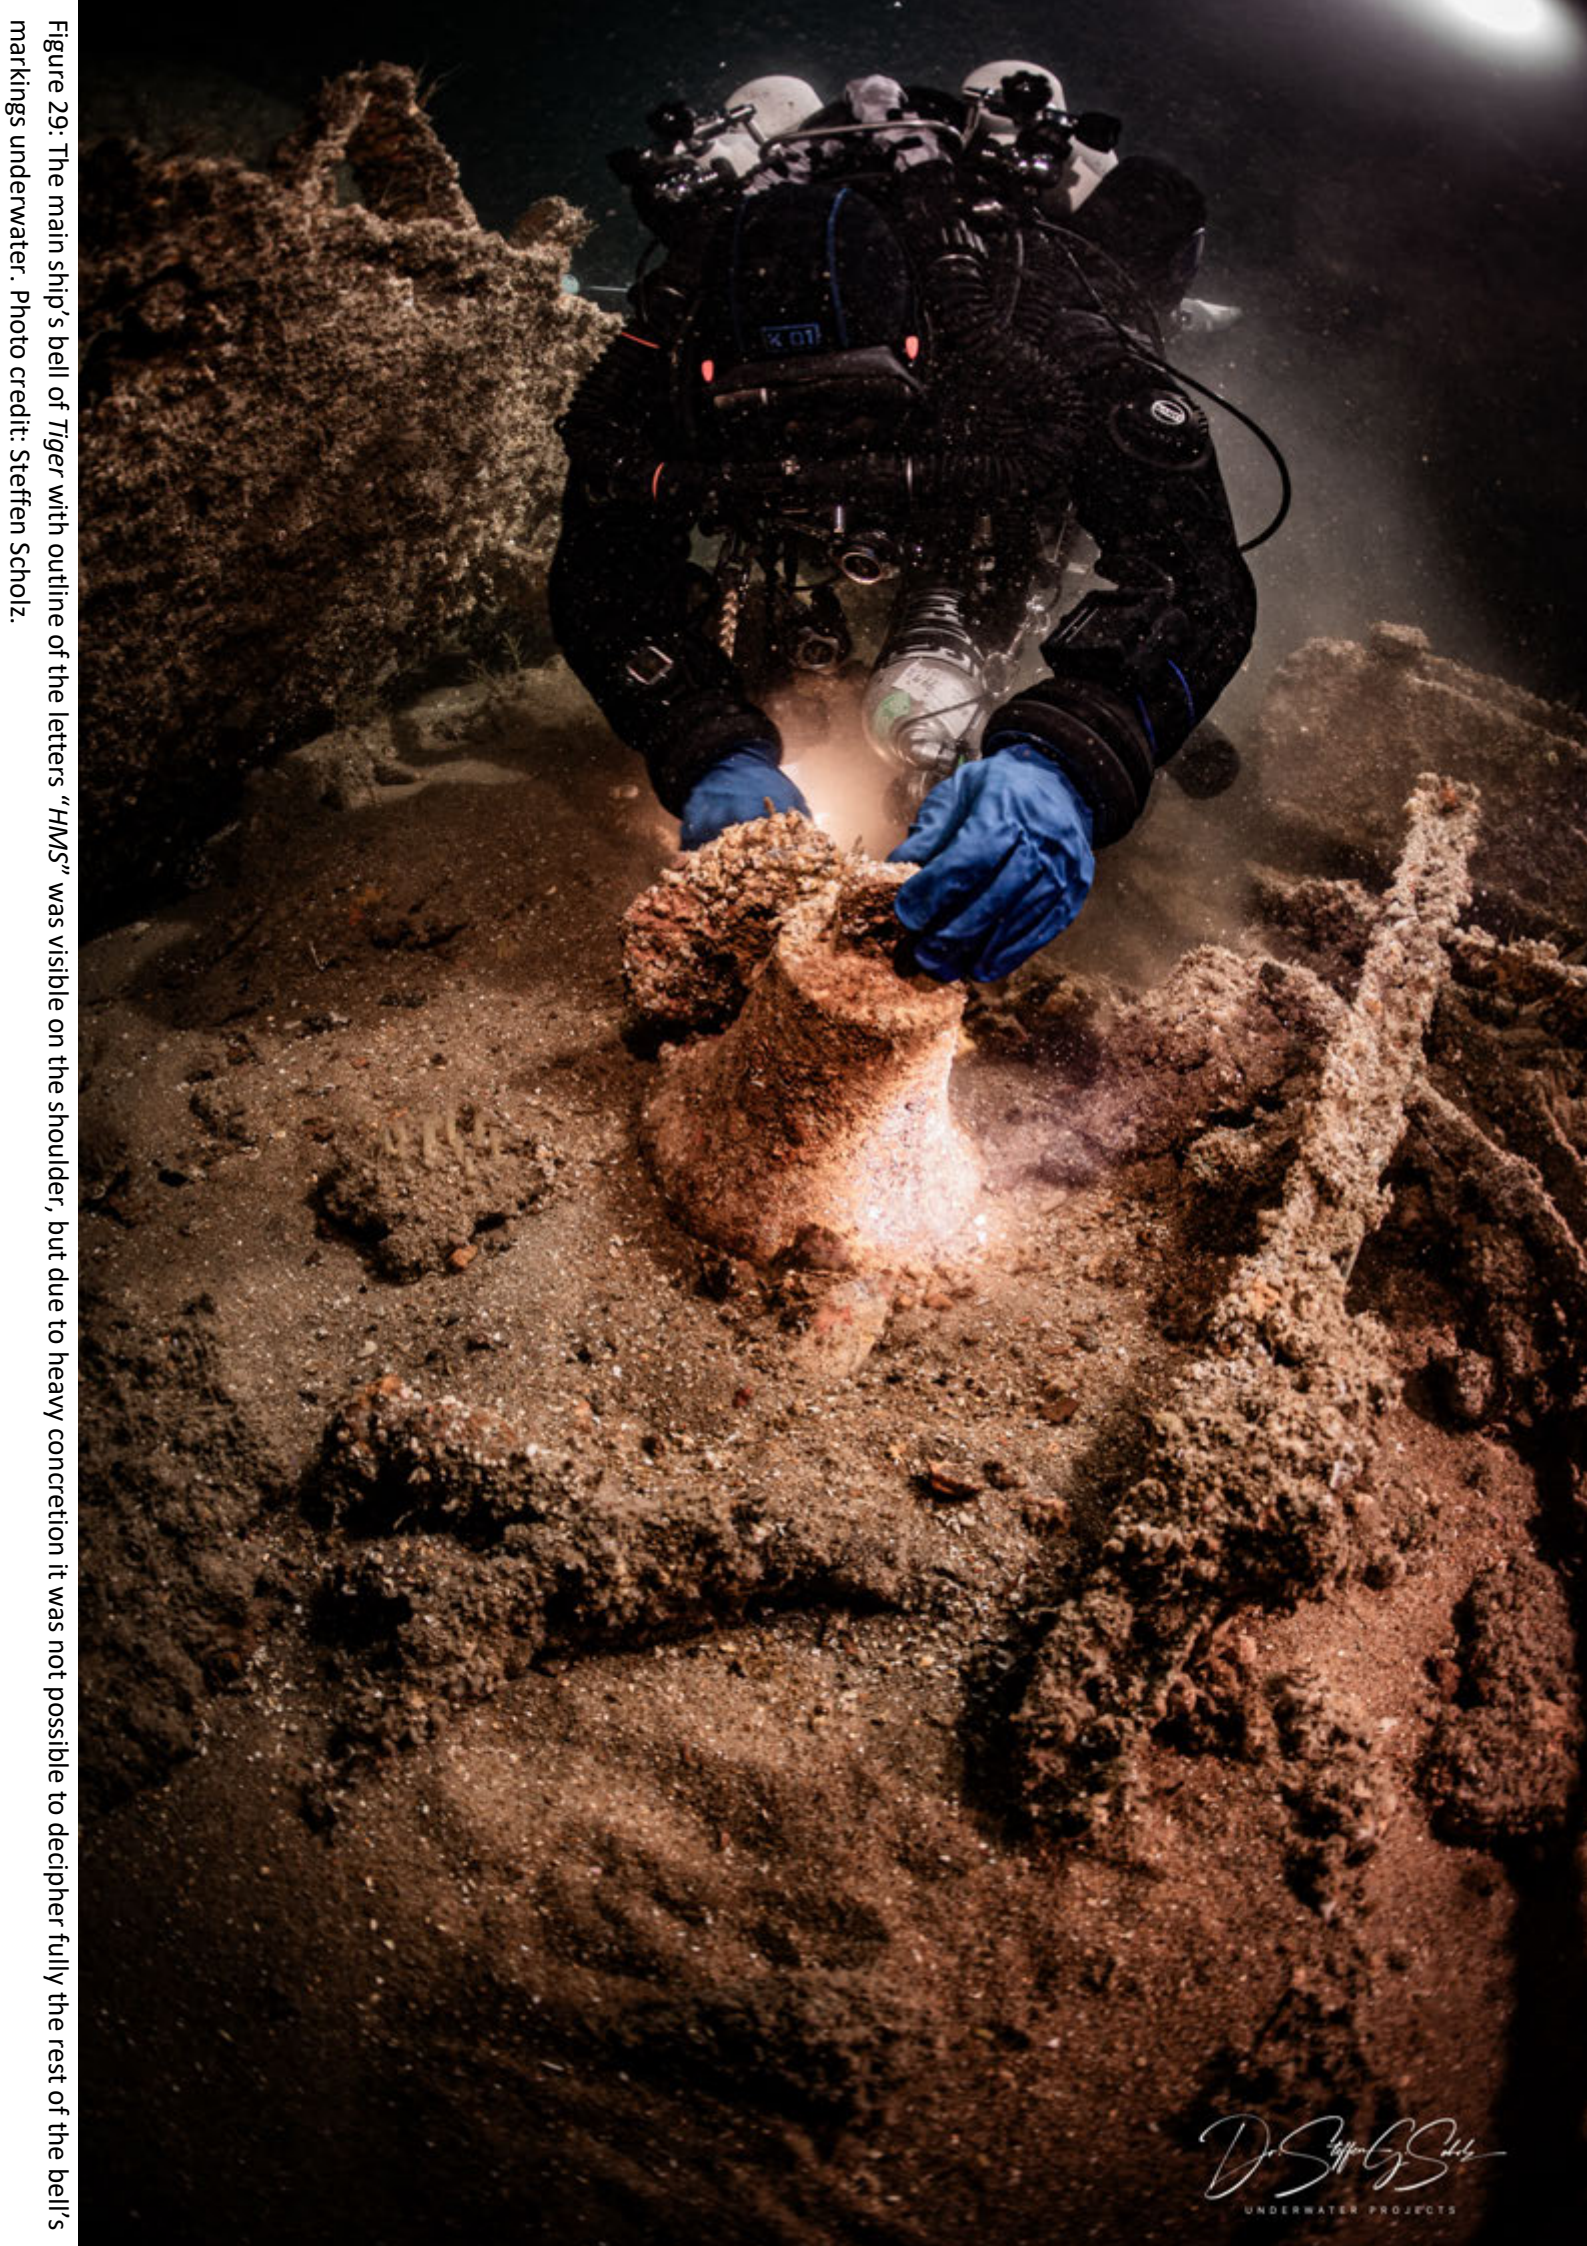
Figure 29: The main ship's bell of *Tiger* with outline of the letters "HMS" was visible on the shoulder, but due to heavy concretion it was not possible to decipher fully the rest of the bell's markings underwater. Photo credit: Steffen Scholz.

Main ship's bell. Low on the starboard side of the wreck, partially hidden underneath the hull around the bridge area, Leo Fielding and Joe Colls Burnett located the main ship's bell of *Tiger*. The diameter of the base of the bell was approximately 30cm with a large eyelet above to hang the bell. Leo Fielding, Joe Colls Burnett, Dan McMullen and Stef Cooper worked to clean the bell in situ to see if the name was discernible under the marine encrustation obscuring much of its surface. The outline of the letters "*HMS*" was visible on the shoulder, but due to heavy concretion it was not possible to fully decipher the rest of the bell's markings underwater.

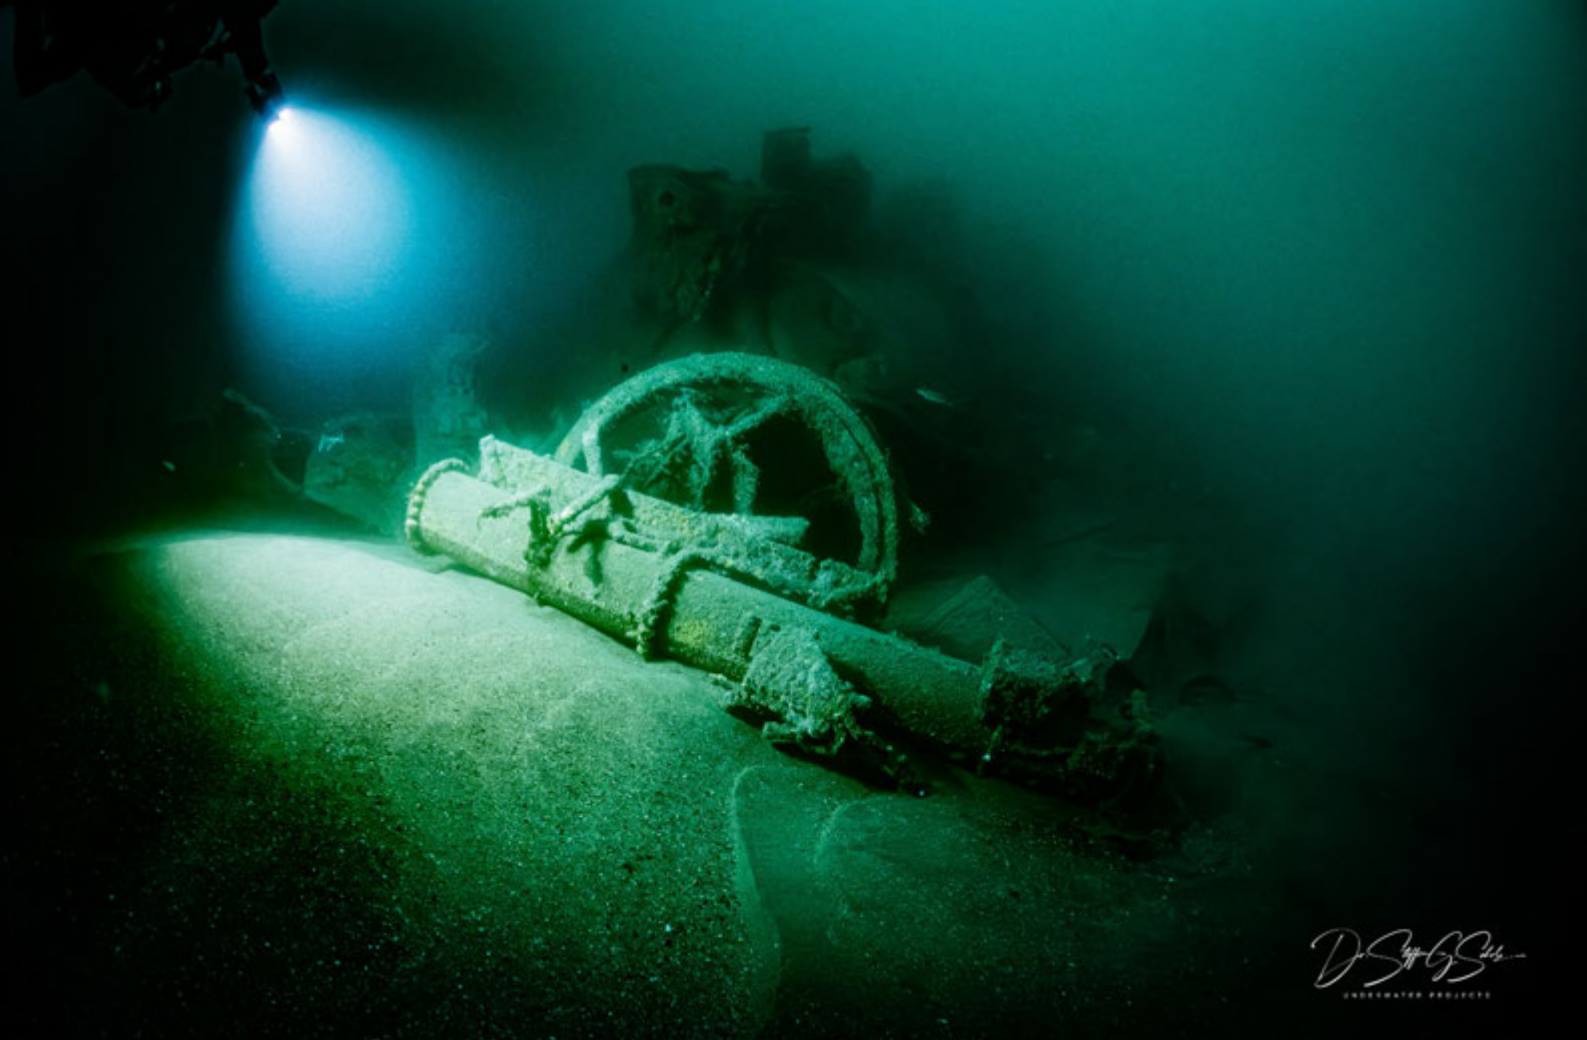
Figure 30 (above): The midships torpedo tube was photographed just in front of the break around compartment number 69. The torpedo tube and slew ring were both fully intact. Photo credit: Dr Steffen G Scholz.

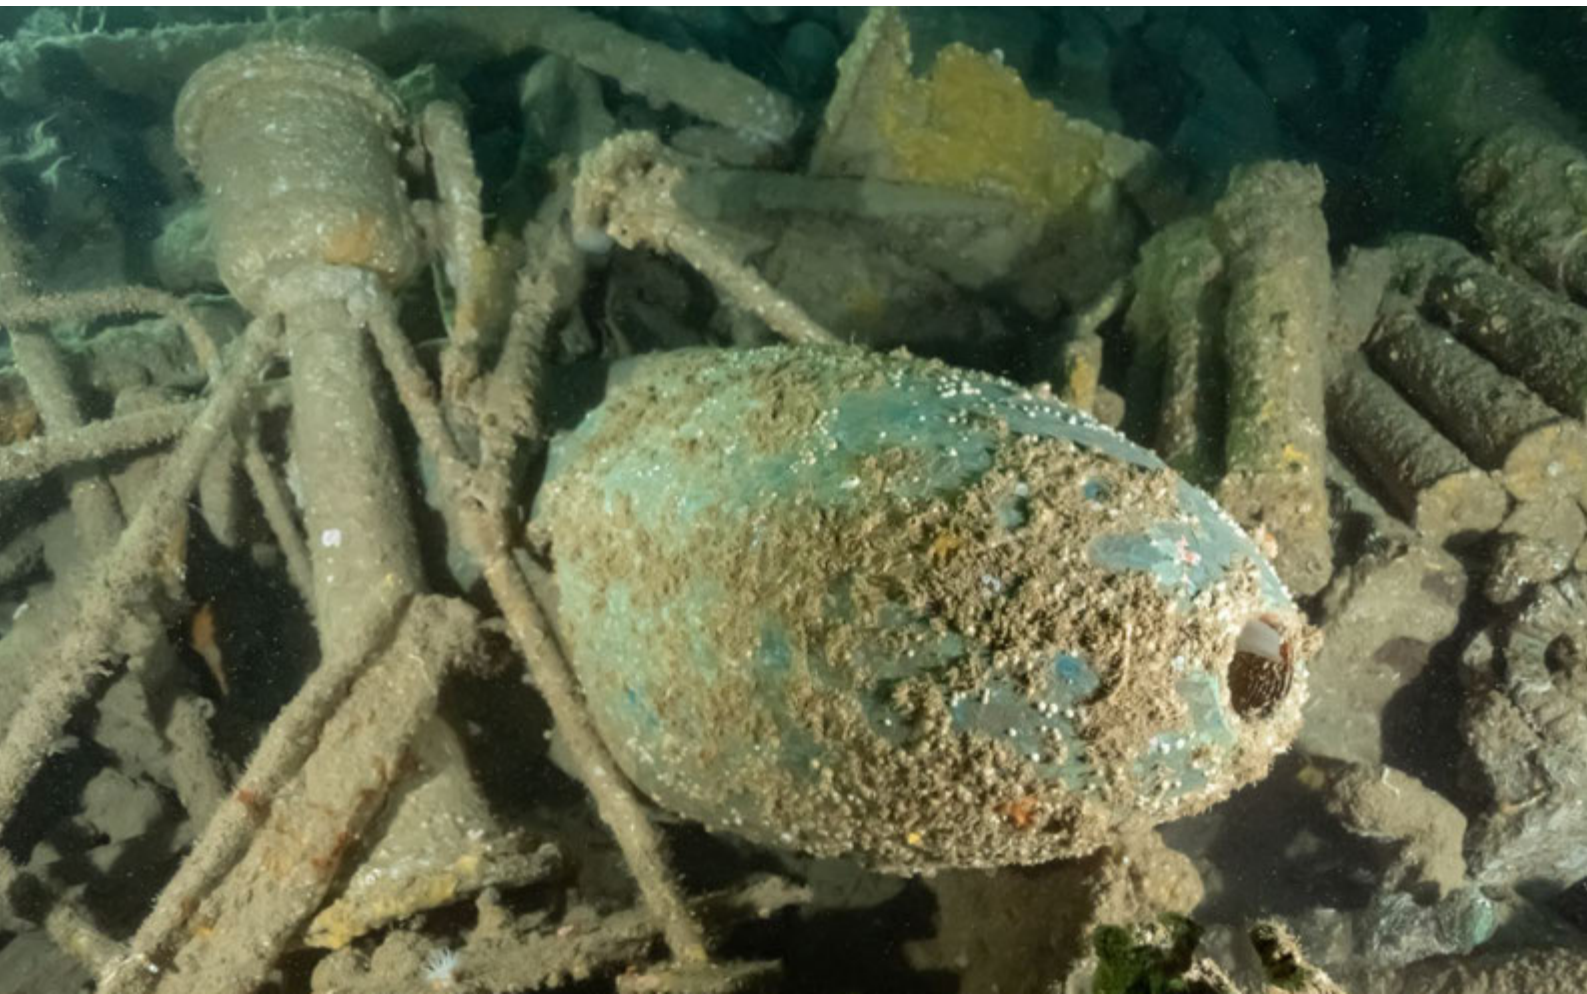
Figure 31 (below): The head of an 18-inch Whitehead torpedo with a threaded hole (“pistol socket”) in the torpedo nose measuring approximately 55mm (2.1 inches) in diameter for fitting the “pistol” that triggered the main explosive charge. Photo credit: Joe Colls Burnett.

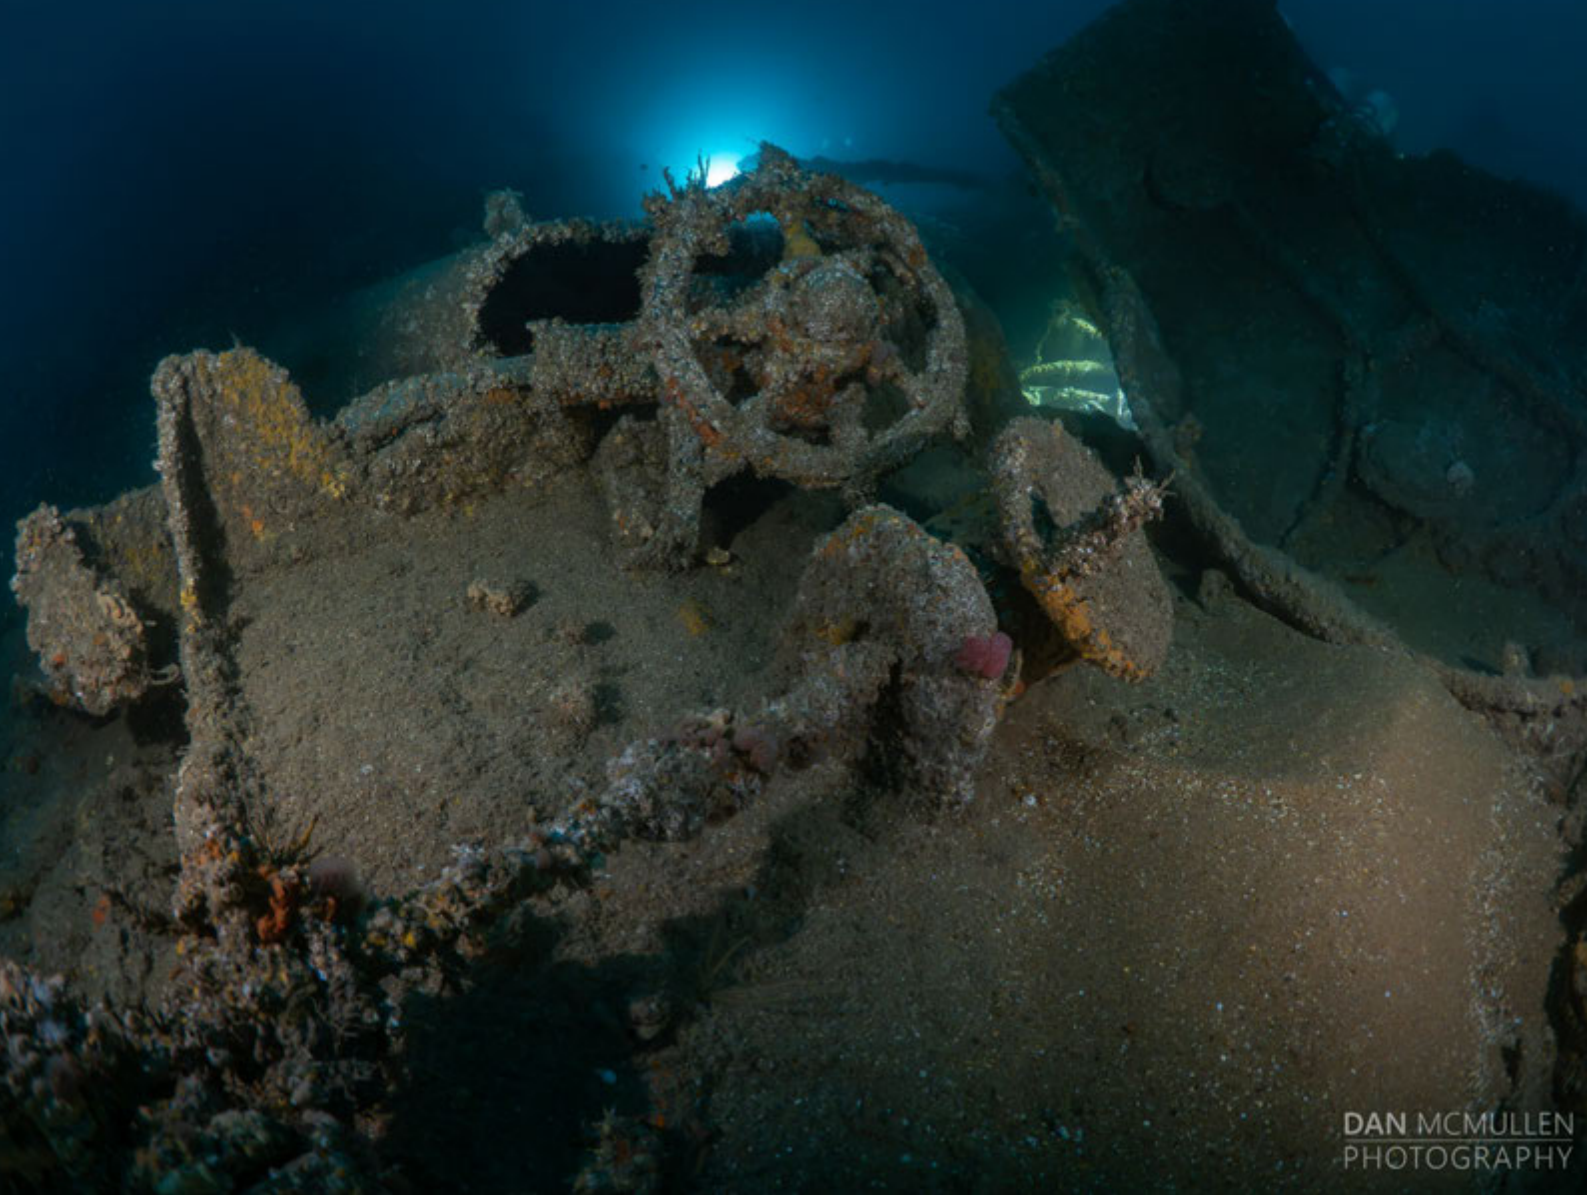
Figure 32 (above): On the bow section, the helm and engine revolution telegraph lay face-up and intact. About 1 metre to port, we located the roof of the conning tower (right-hand side), which would have been fitted immediately beneath the 12-pdr. gun mount, inverted on the seabed, resembling the shell of an upturned turtle. Photo credit: Dan McMullen.

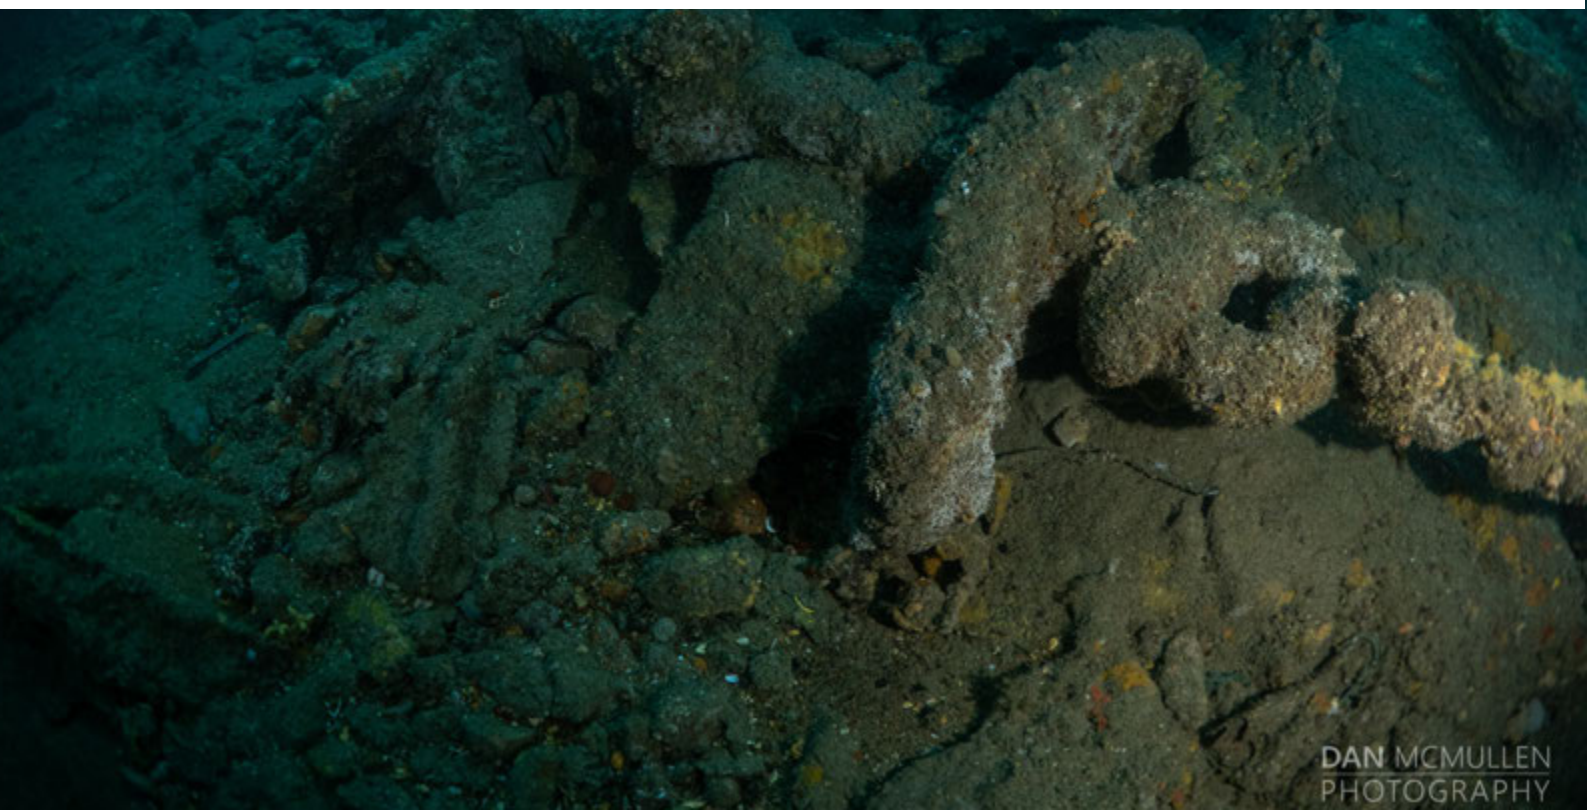
Figure 33 (below): On the bow section, Stef Cooper located one of the two kedge anchors on the starboard side of the turtledeck as expected around compartments 23 to 25. Photo credit: Dan McMullen.

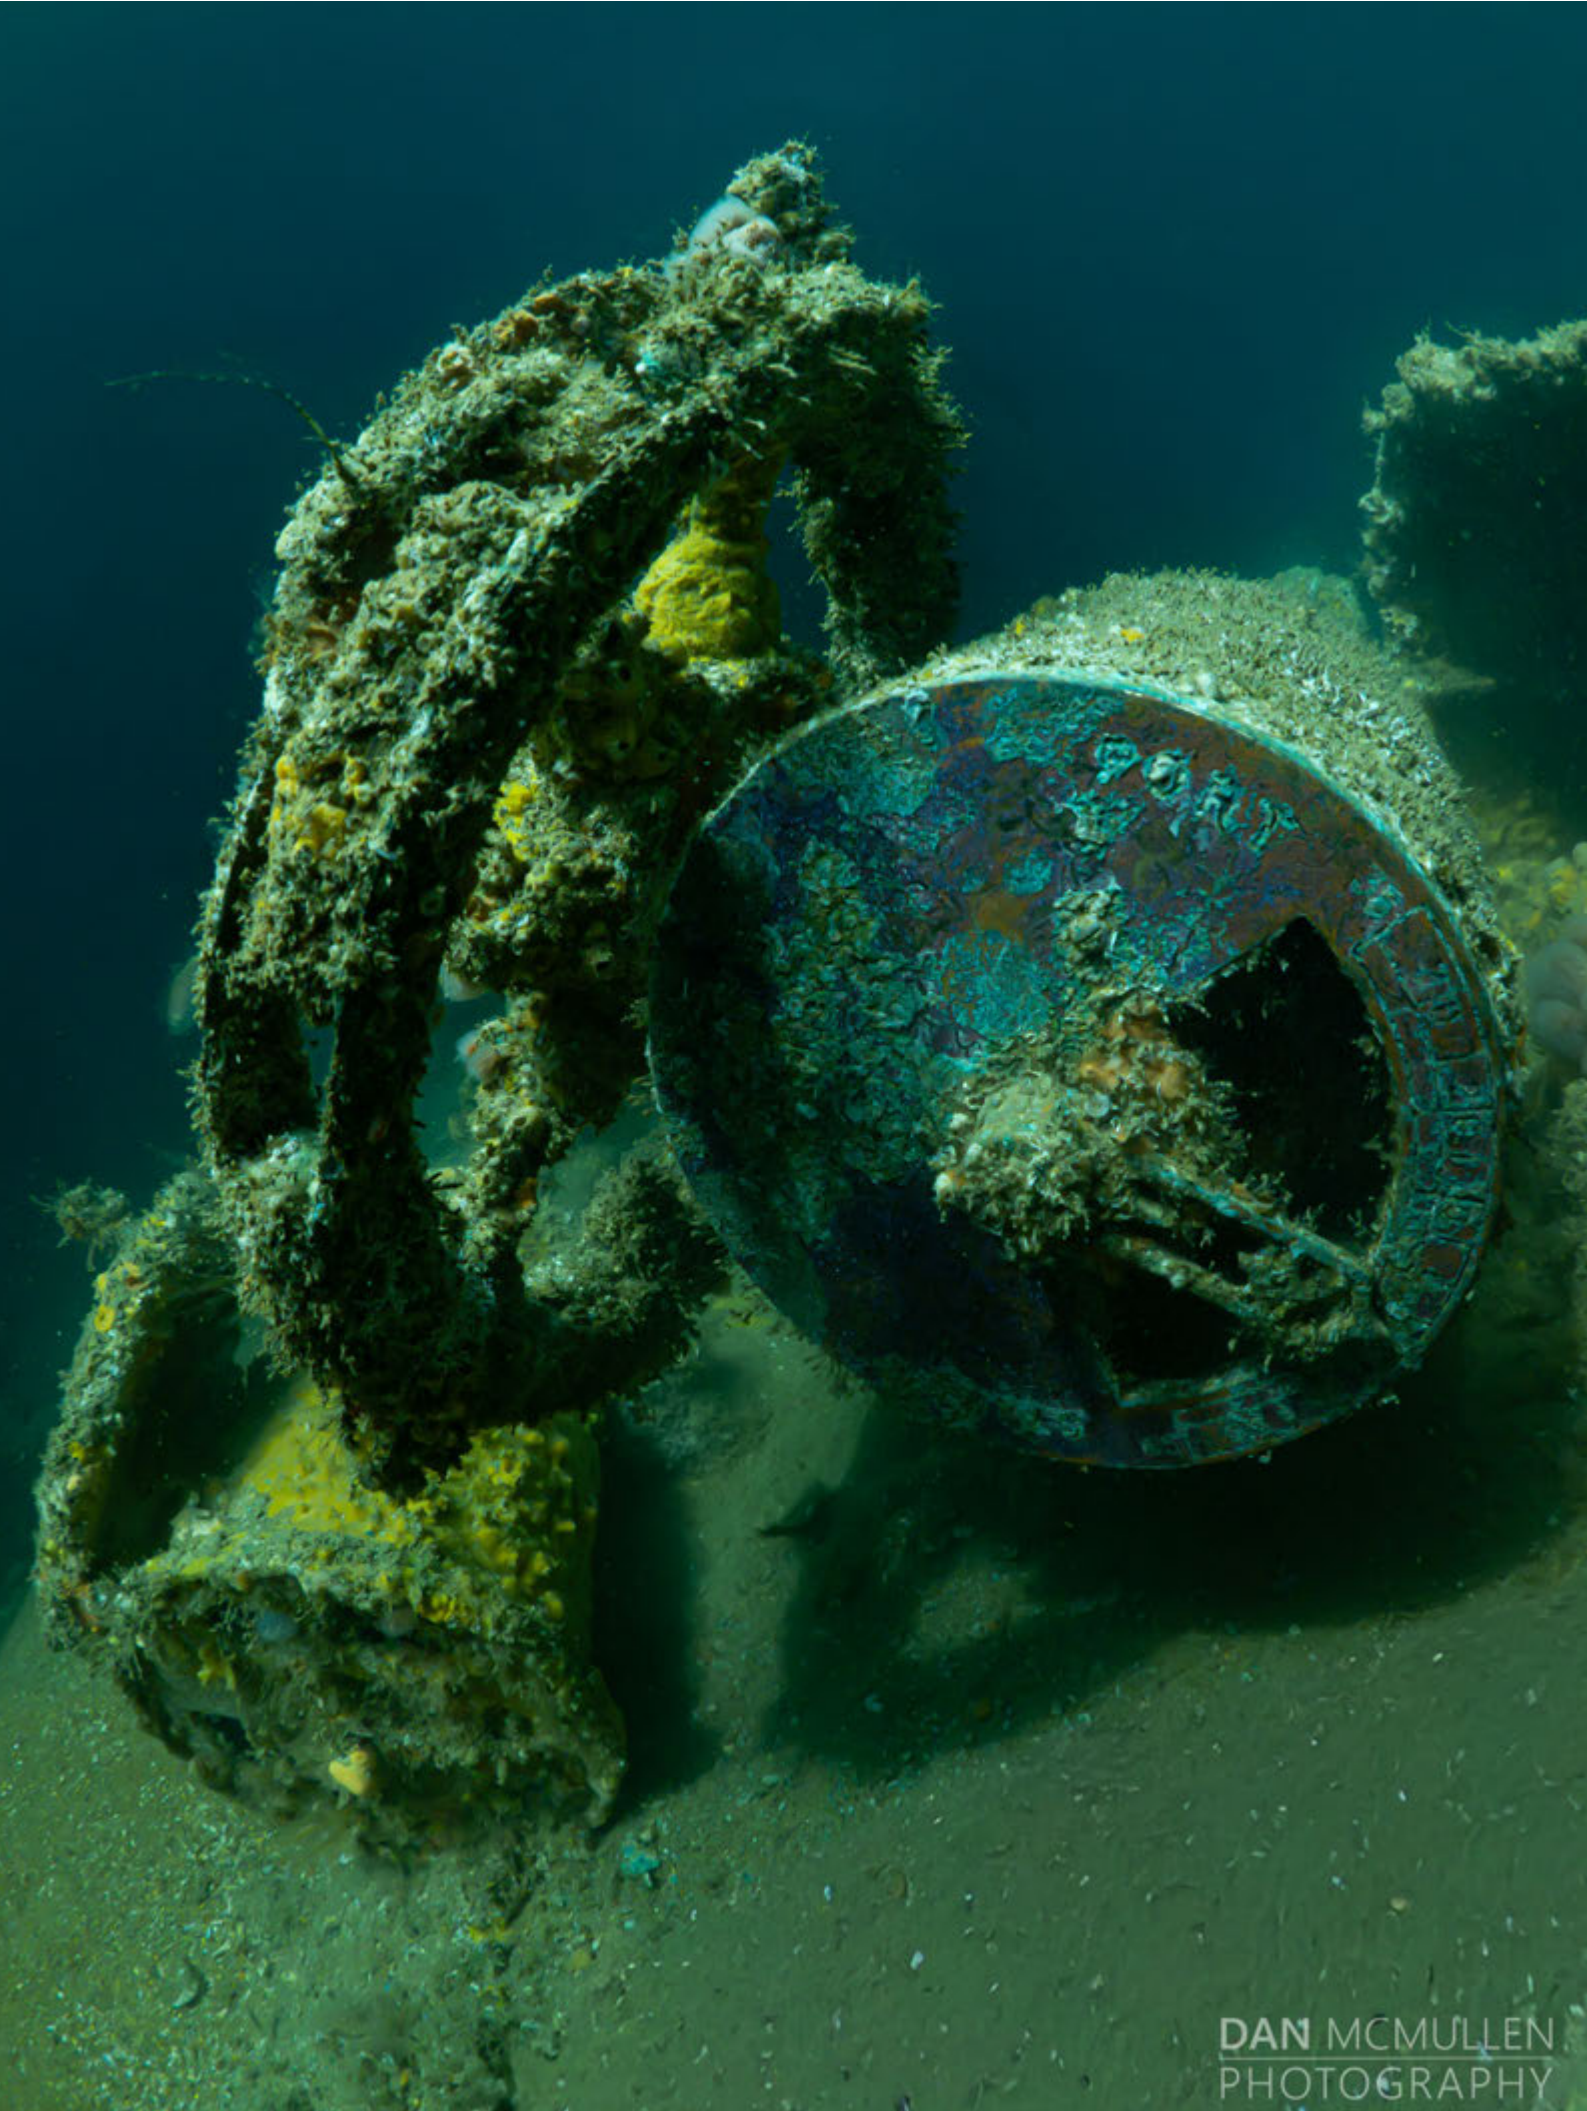
Figure 34: The rudder position indicator. The graduated circular scale is marked "PORT" and "STARBOARD". The pointer mechanism is set to approximately 5-10 degrees to starboard, which suggests that *Tiger* had not altered course to avoid *Berwick* immediately prior to the impact. Photo credit: Dan McMullen.
